# Port Sunlight Landscape Condition Survey Report

Port Sunlight Village Trust

Prepared by Ryder Landscape Consultants

July 2017

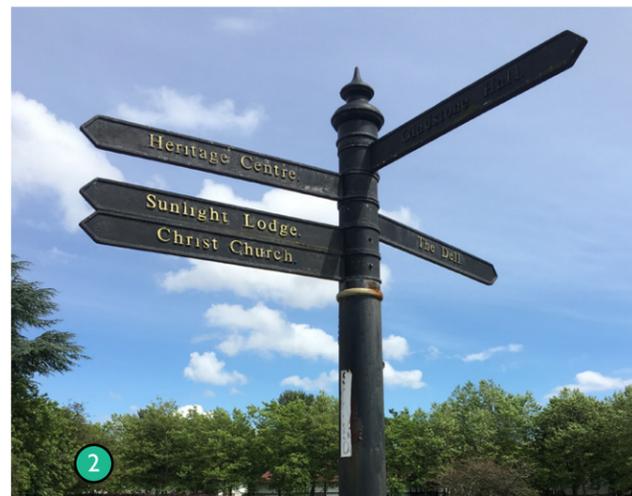
**Character Area 3**  
Finger post, Bolton Road

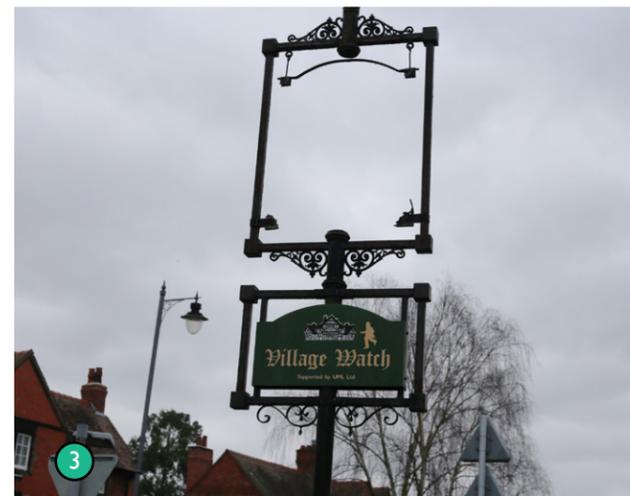
**Character Area 3**  
Incomplete name sign - otherwise in good condition, Green-dale Road

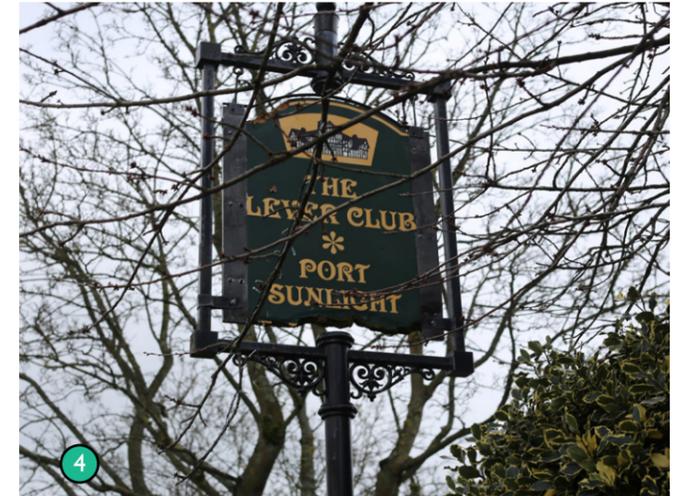
**Character Area 3**  
Damaged Lever Club sign

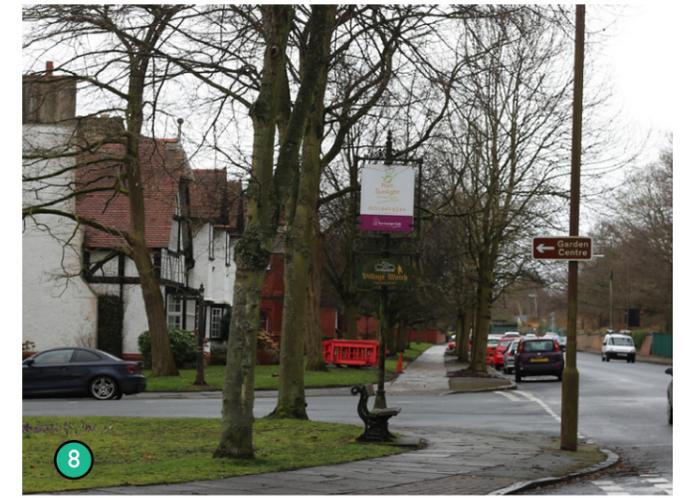
**Character Area 7**  
Garden Centre navigation signs, Greendale Road/The Causeway

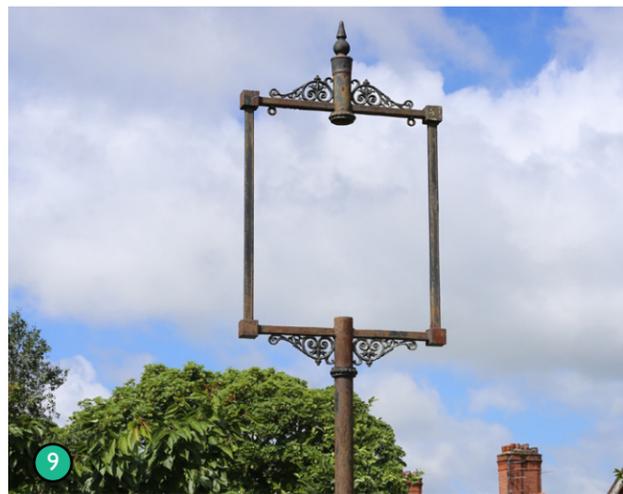
**Character Area 8**  
Incomplete sign in poor condition, New Chester Road

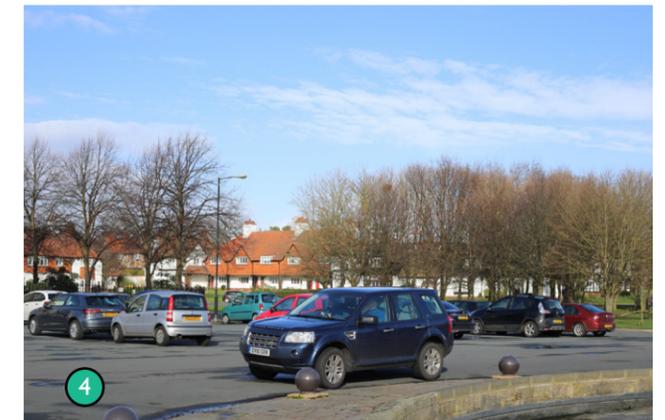
**Character Area 9**  
Informal parking outside the Diamond

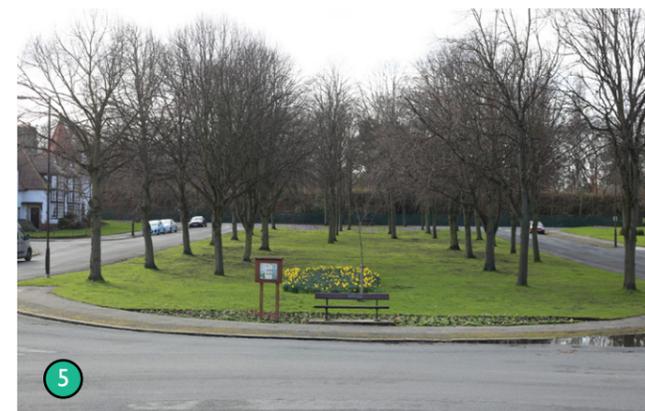
**Character Area 9**  
The Causeway - lack of pedestrian navigation (for road crossing) or road markings for vehicle users

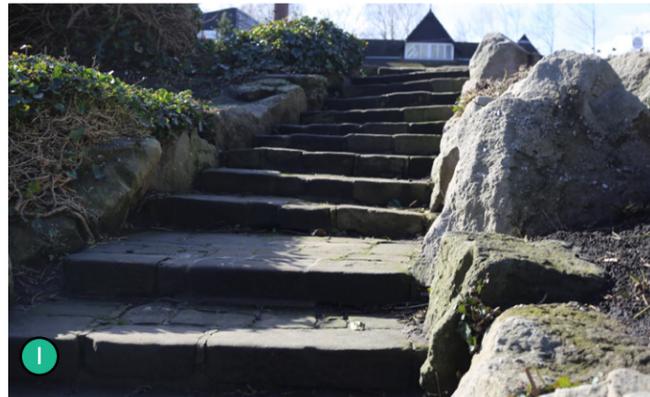
**Character Area 2**  
Steps into the Dell - trip/slip hazard, characterful but no handrail

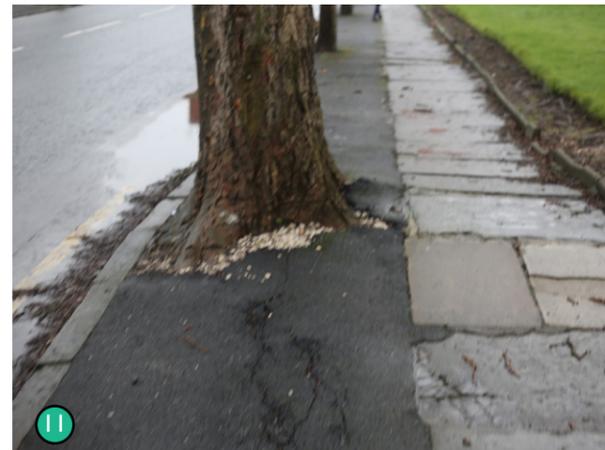
**Character Area 5**  
Paving with root heave and uneven surfaces- trip/slip hazard

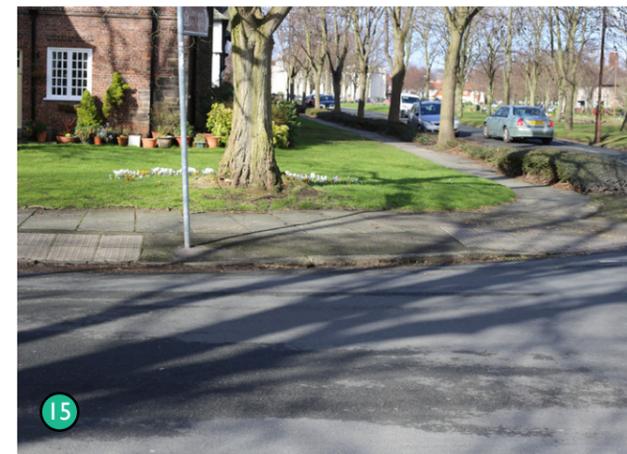
**Character Area 8**  
The Ginnel - lack of hazard warning paving at pedestrian crossing point

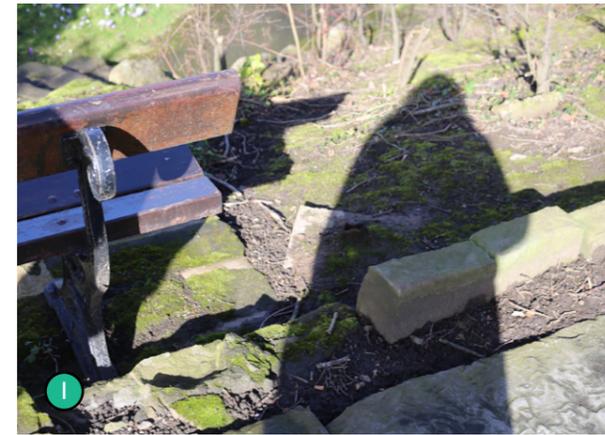
### Character Area 2

Damaged paving outside the Dell - trip hazard

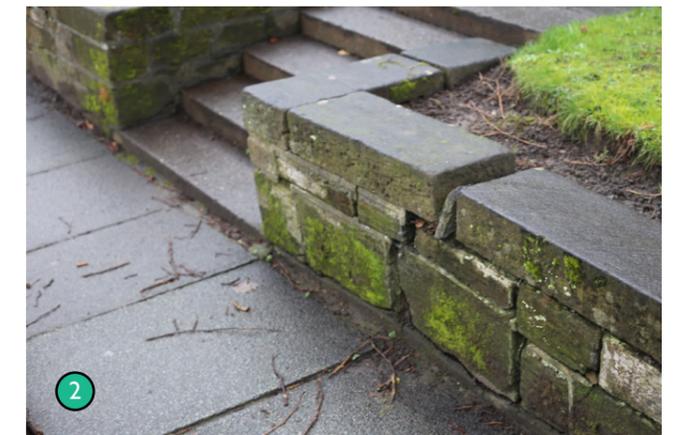
### Character Area 7

Damaged retaining wall, Queen Mary's Drive - collapsing blocks

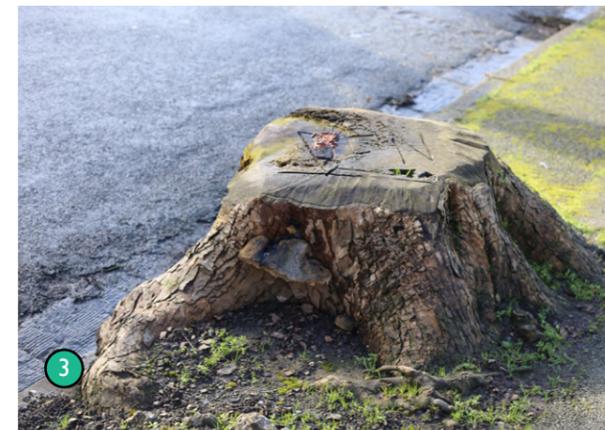
### Character Area 8

Tree stump leftover in paving - trip hazard

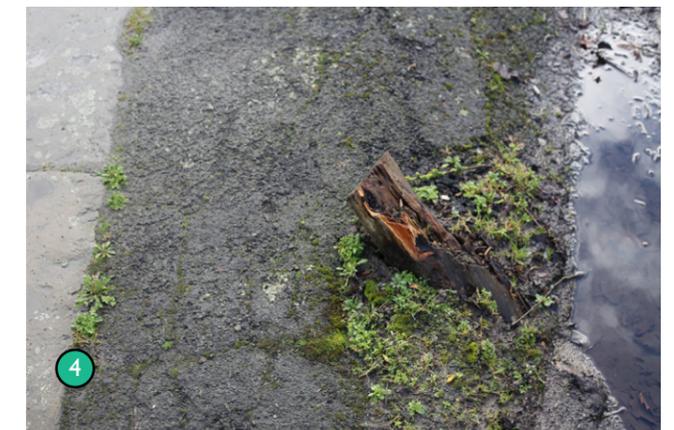
### Character Area 8

Tree stump in paving - trip hazard

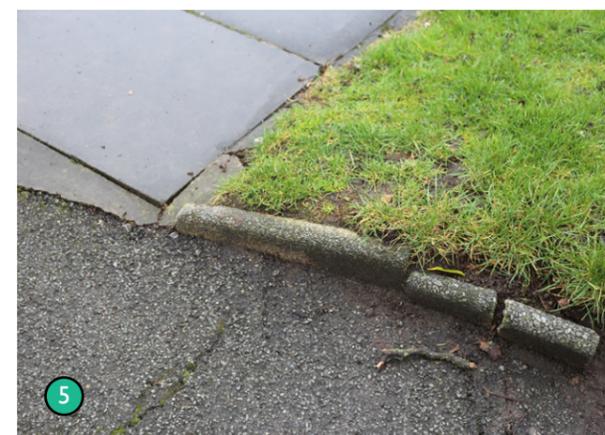
### Character Area 7

Damaged kerb edge - trip hazard

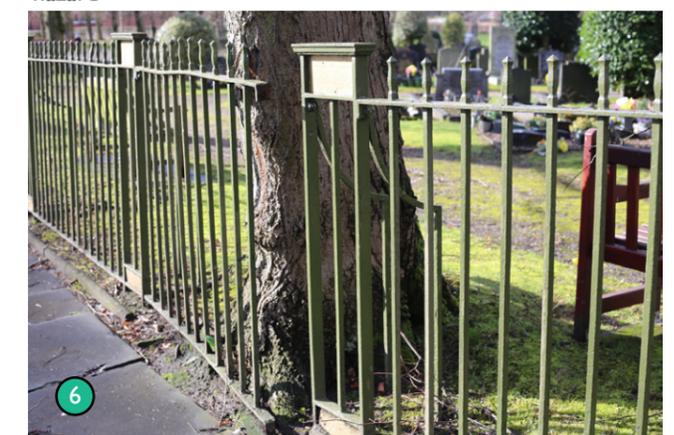
### Character Area 10

King Edward's Drive, Church railing damaged by trees - tripping hazard
