Brief: Commissioning a Conservator for the Gladstone Plaque, Port Sunlight

Port Sunlight Village Trust (PSVT) seeks to commission an ICON accredited conservator to undertake treatment to the bronze Gladstone Plaque, located on the front of the Gladstone Theatre, Port Sunlight.

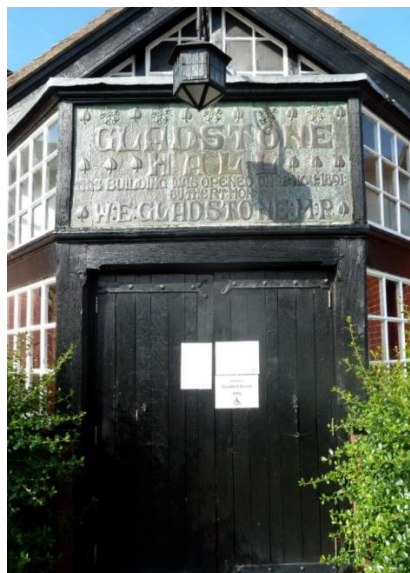
The plaque is comprised of five panels of beaten bronze sheets installed on a timber panel above the external door to the Grade II Gladstone Theatre, located in Port Sunlight conservation area. The plaque is highly significant for the theatre, and a very visible part of heritage in the village.

Figure 1: Gladstone Plaque, located above entrance to Gladstone Theatre

Structurally, the plaque comprises five sections of thin beaten bronze, attached by screws and nails onto an unseen (probably wood) backing board of unknown condition. There are gaps between each section of the bronze panel. The open spaces have filled with detritus, and it is likely that water will be penetrating in and rotting the wooden support behind.

The plaque has a wooden surround which has been painted black. The top edge of the plaque is tucked under the upper frame edge, which latter holds it in place at the top. The other three sides sit within the inner edges of the frame.

There appear to be several previous attempts to prevent water ingress behind the plaque, including caulk (which has failed). On the bottom edge, the wood surround has rotted away entirely, leaving nails clinging to splinters and fillers stretched over a wide gap and adhering at random points. A visual chronology for the plaque indicates that it was repatinated in the twenty-first century to have a dark brown finish. The bronze surface is now characterised by disfiguring and uneven green corrosion.

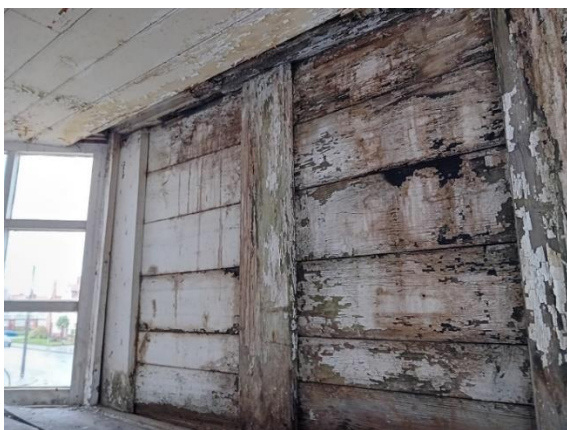
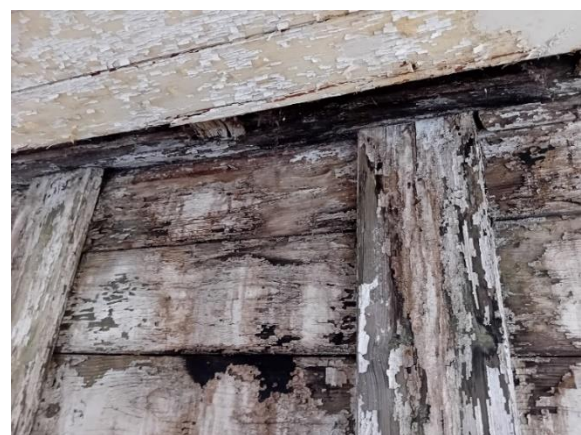
To the rear of the plaque (inside the theatre), tongue and groove boarding is visible (see image below). Inspection of the roof around the panel shows the plaque is screwed to the tongue and groove timber which in turn is secured to the oak timber uprights of the frame for the porch. Although heavily water stained from a roof leak, these timbers appeared in good repair (January 2024) but should be assessed as part of this scope of works once the plaque is removed.
