# Port Sunlight Landscape Condition Survey Report

Port Sunlight Village Trust

Prepared by Ryder Landscape Consultants

July 2017

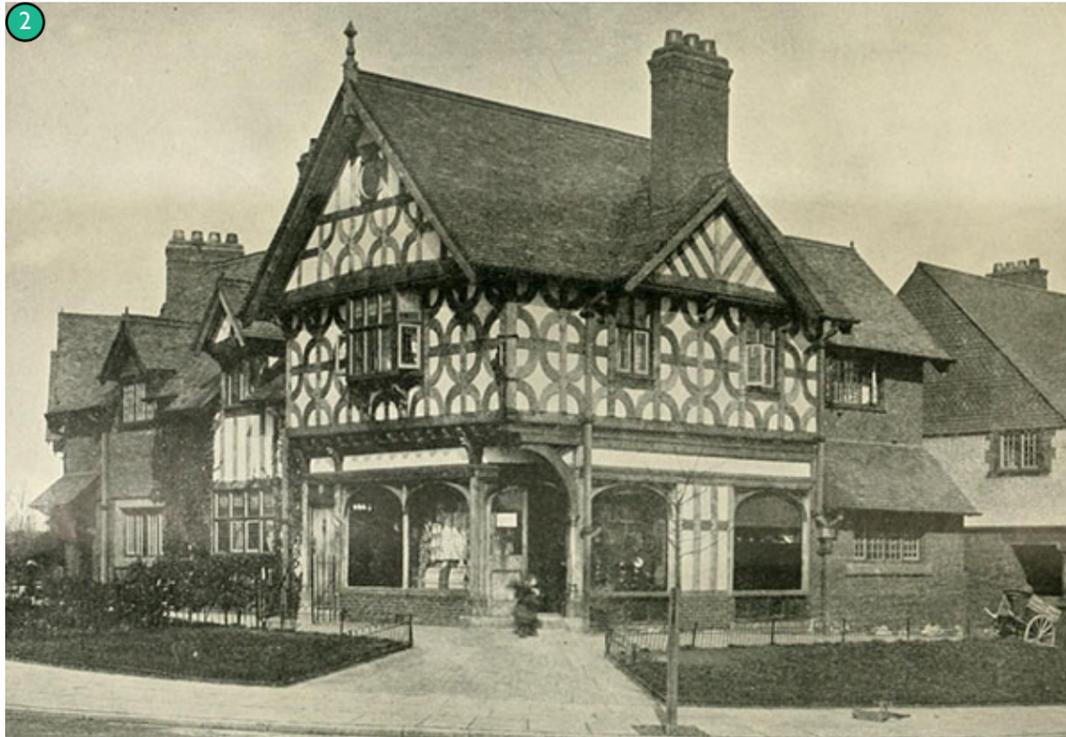
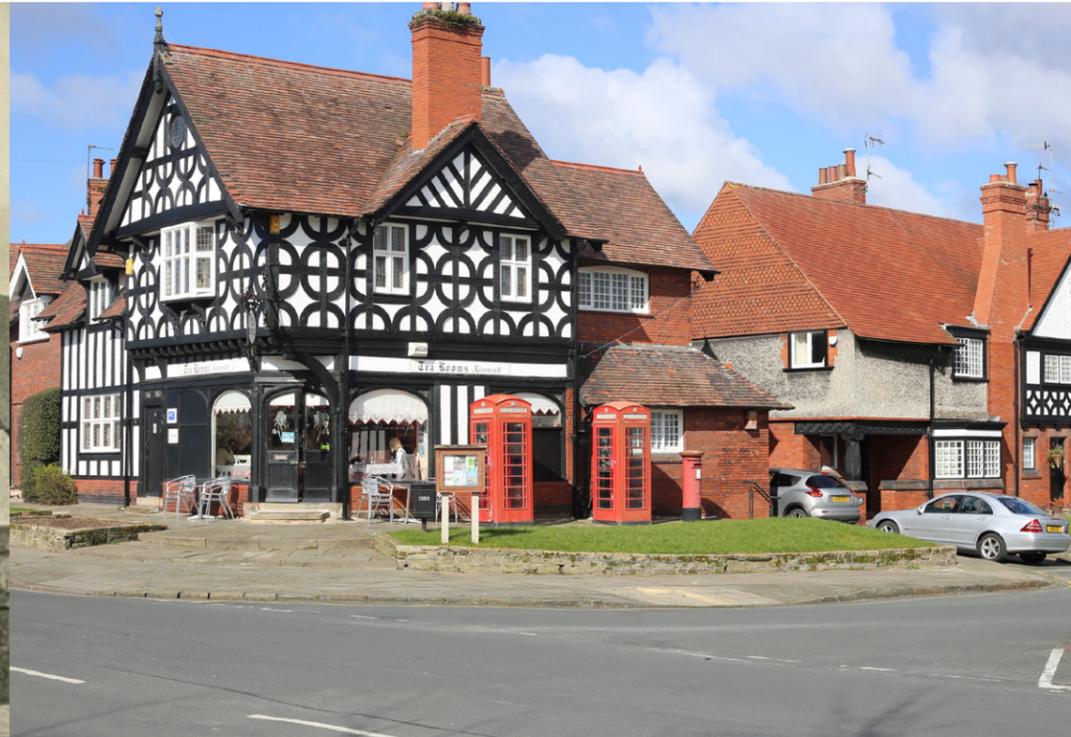
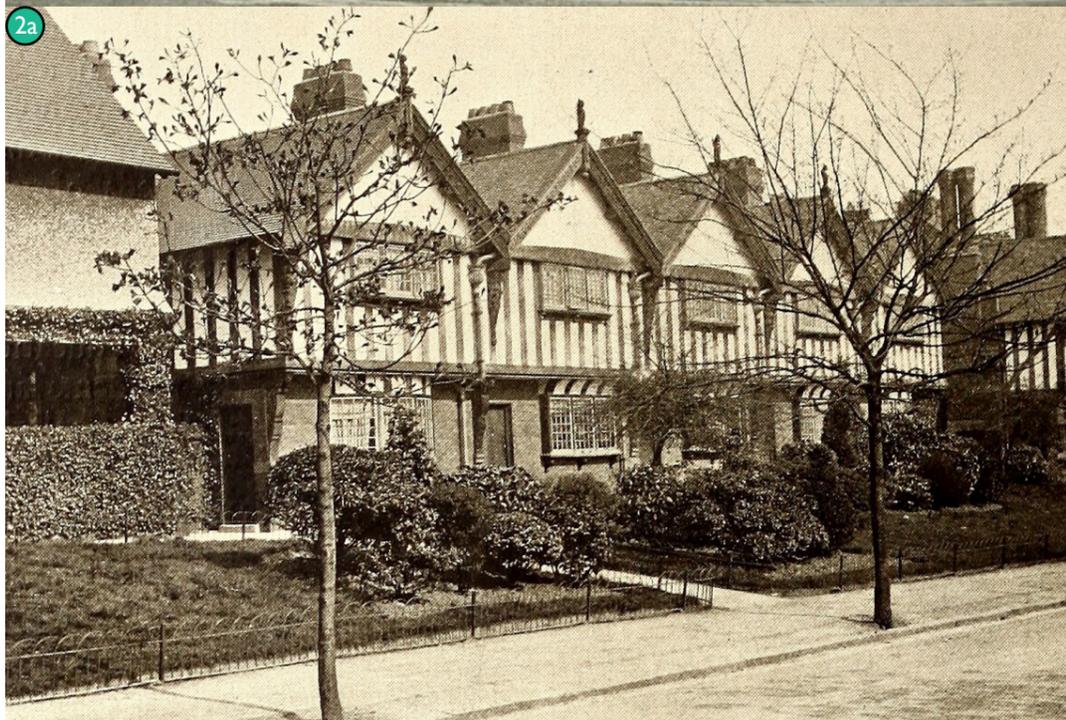
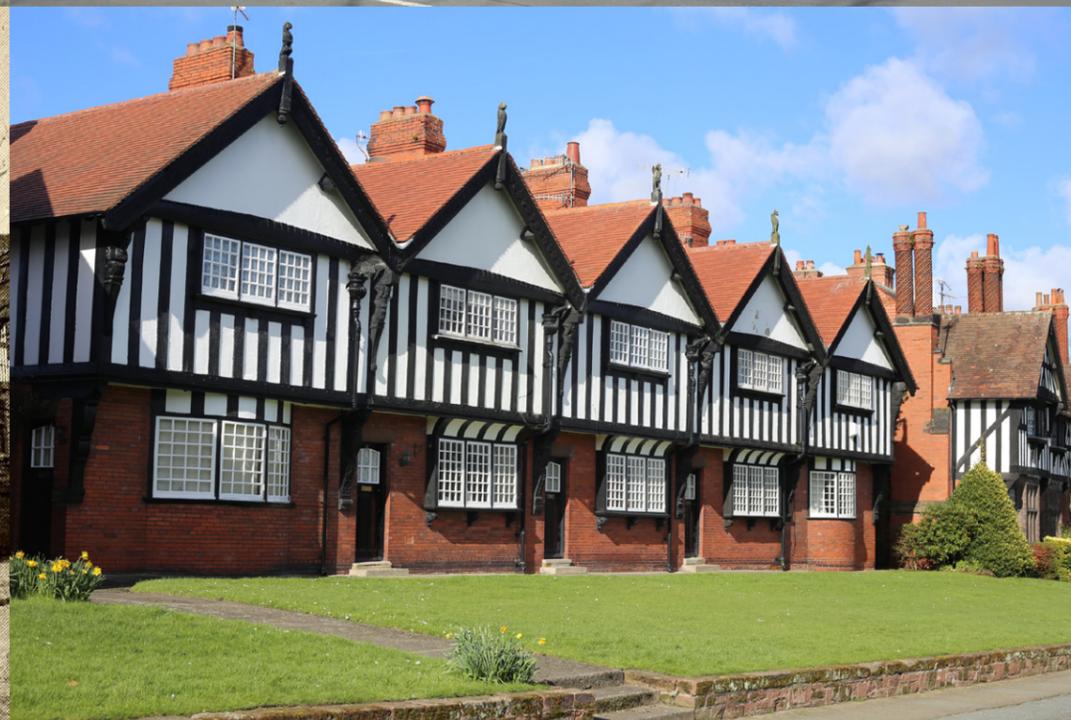
An open tree lined street with grass fronts lawns and railings\* along Park Road with a shop at the junction with Greendale Road.

Overall management recommendation would be to maintain the status quo within this area, however a review and rationalisation of street furniture (raised planters, signs, phone boxes etc.) outside The Tudor Rose Tea Rooms would help in terms of legibility and maintain a clear street aesthetic and sense of space at this junction.

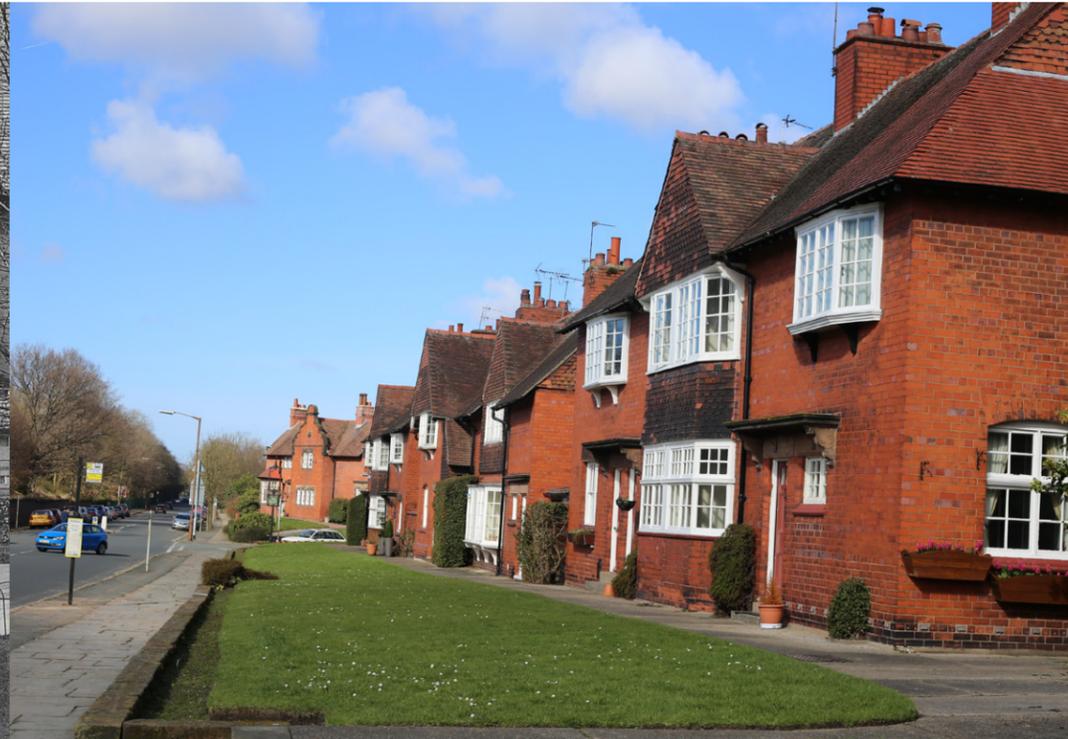
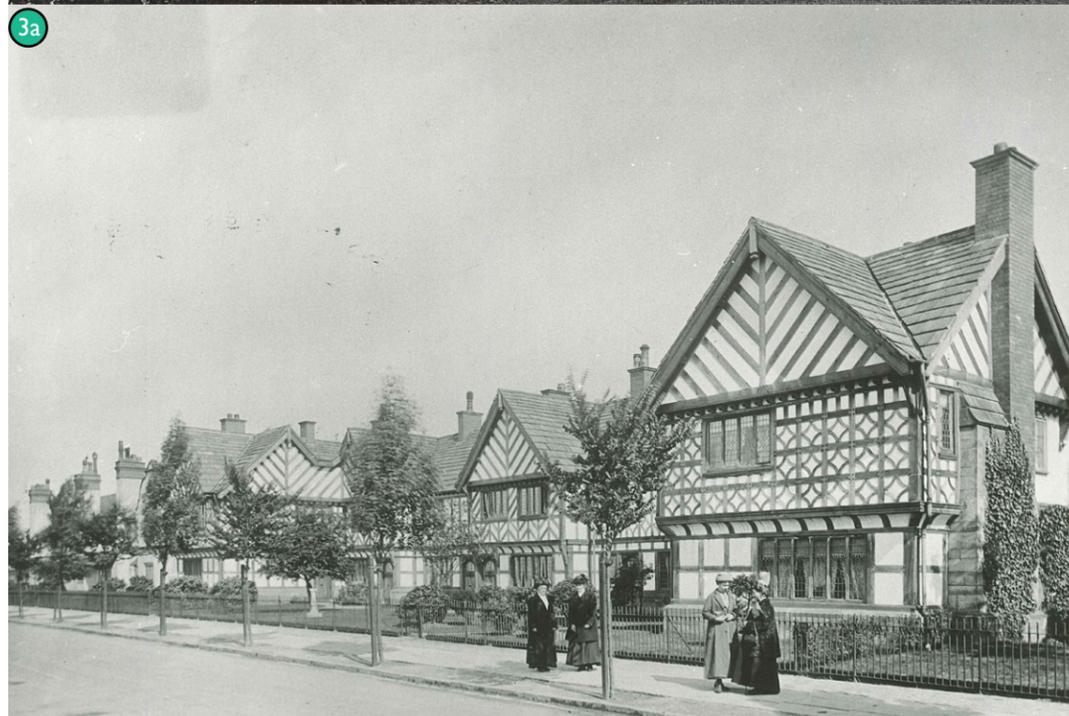
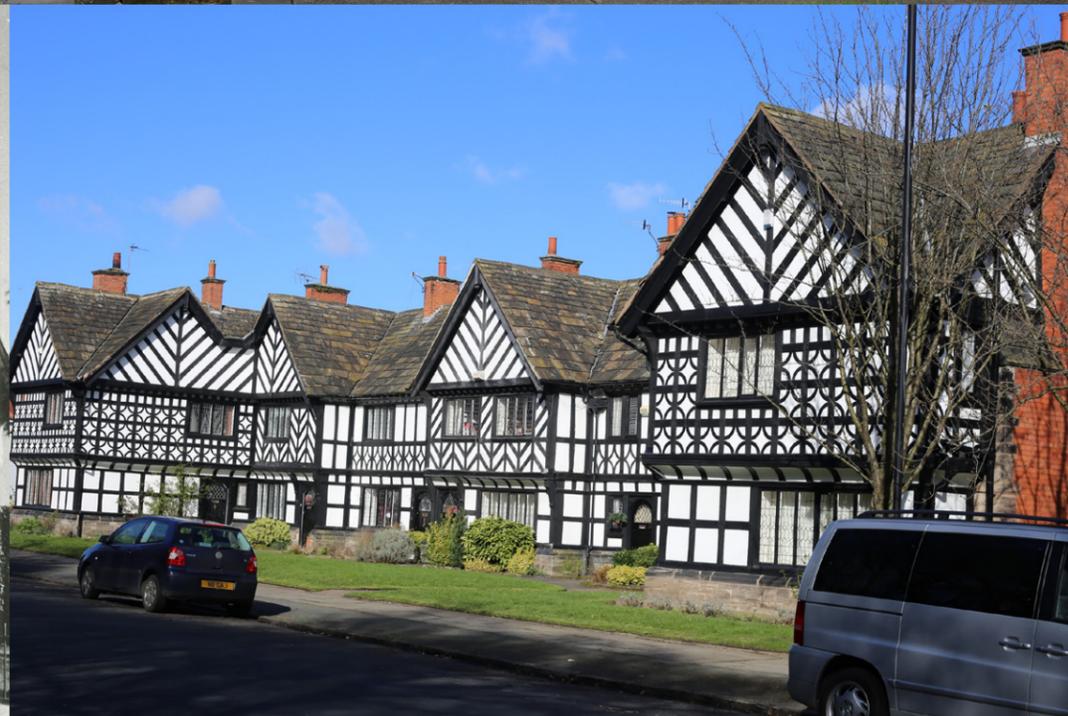
A tree lined street (likely poplars) with low railings, shrubs (laurel) and specimen tree species to property frontages.

Even though the view focus is on the property, it is largely different from the original design or character through the loss of landscape features. Maintenance of this 'new' character along Greendale Road is recommended including infilling of the unfilled gaps. A long term aspiration could be the introduction of specimen tree species to complement the property frontages.

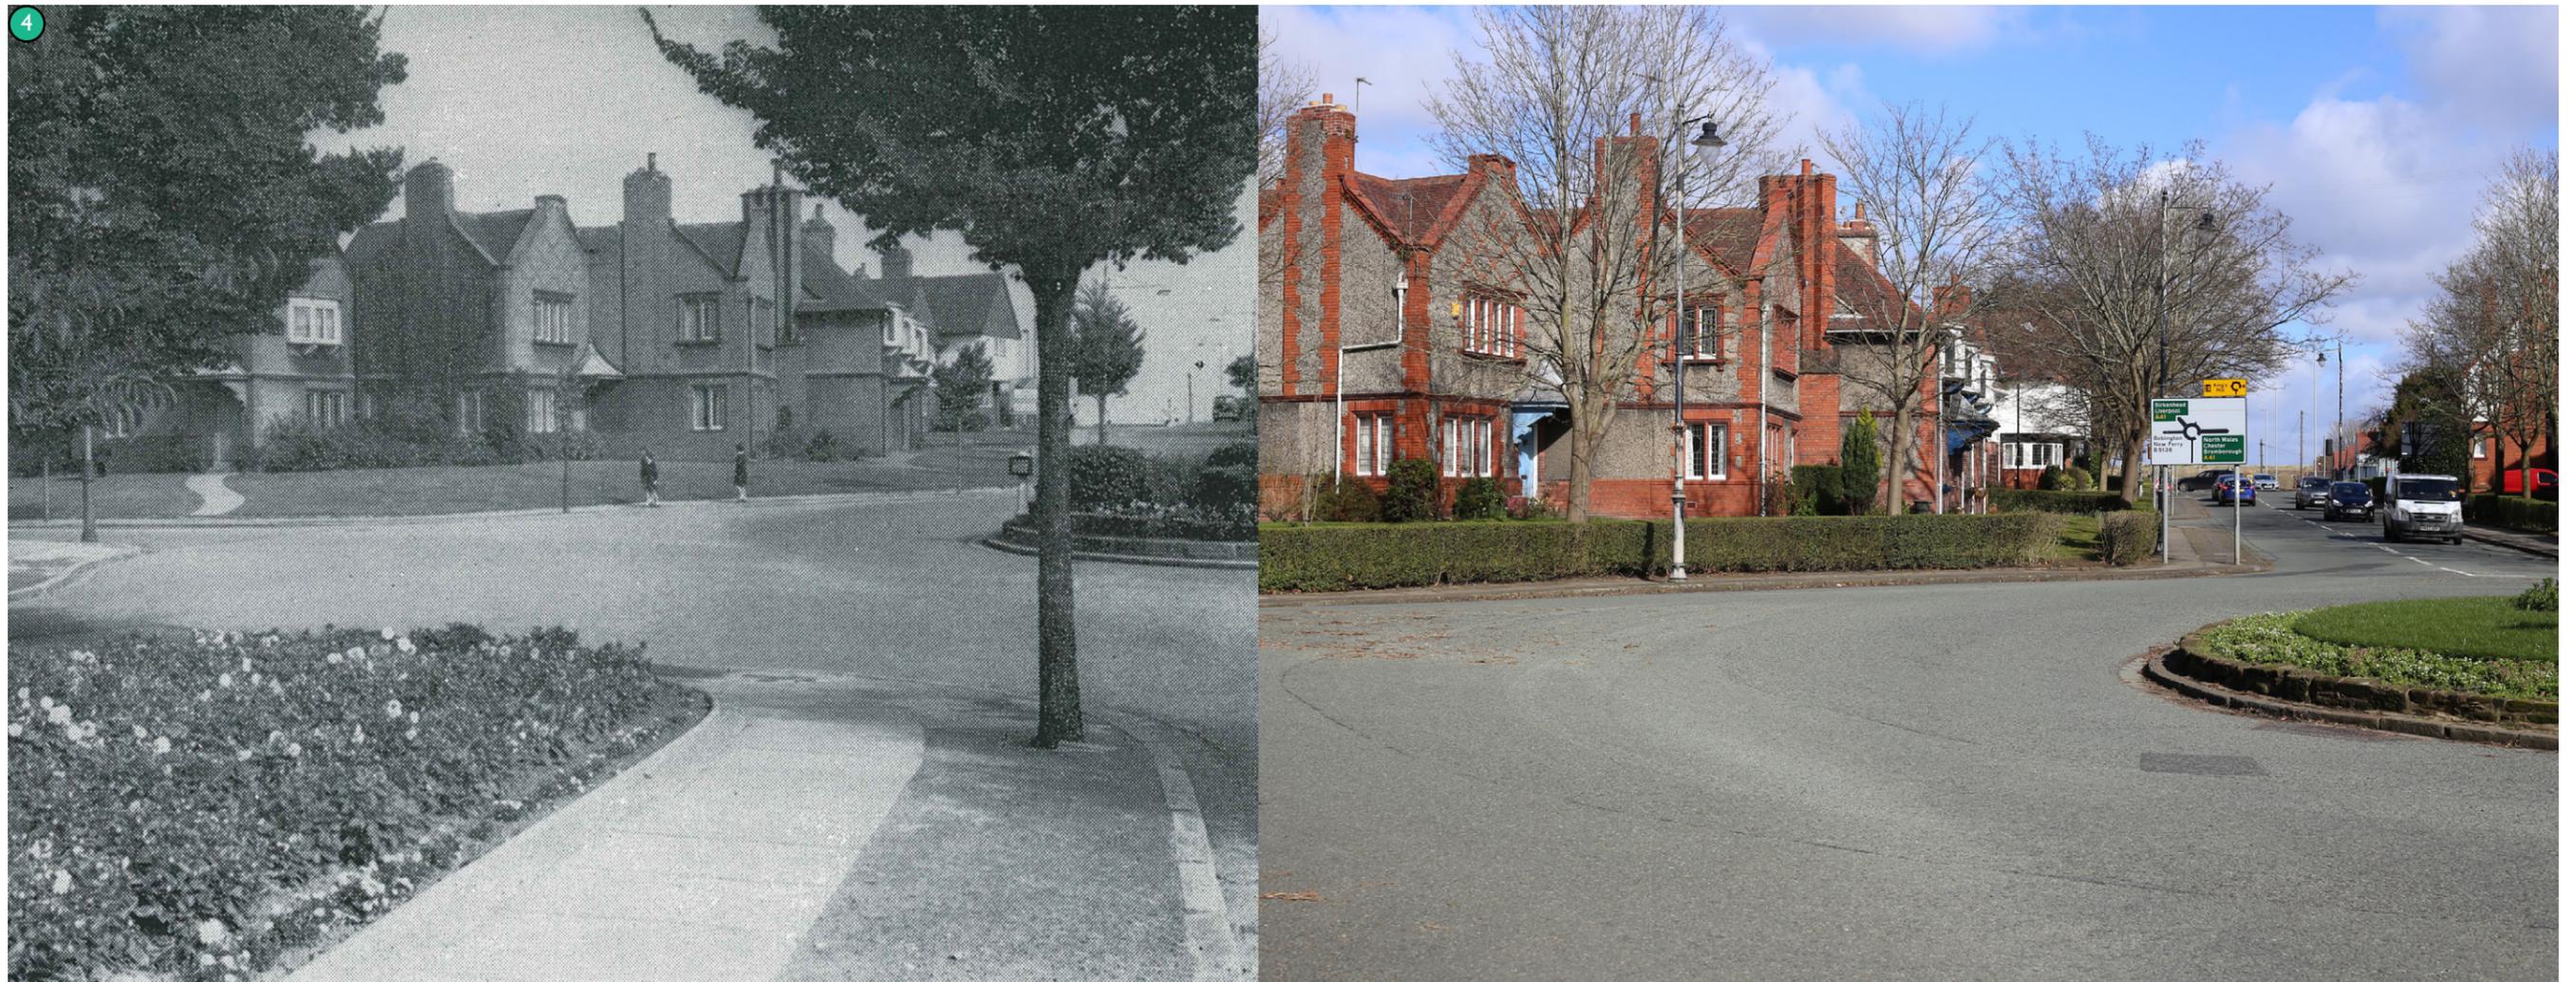
A tree lined street with amenity planting, open property fronts and Bolton Road Roundabout acting as feature.

The view is mainly intact, with some additions over time slightly altering the character of the street including old to contemporary road signs. A wider review of the hierarchy of road signage across the village is recommended. Simple maintenance works to lighting columns and trees in front of properties is required.

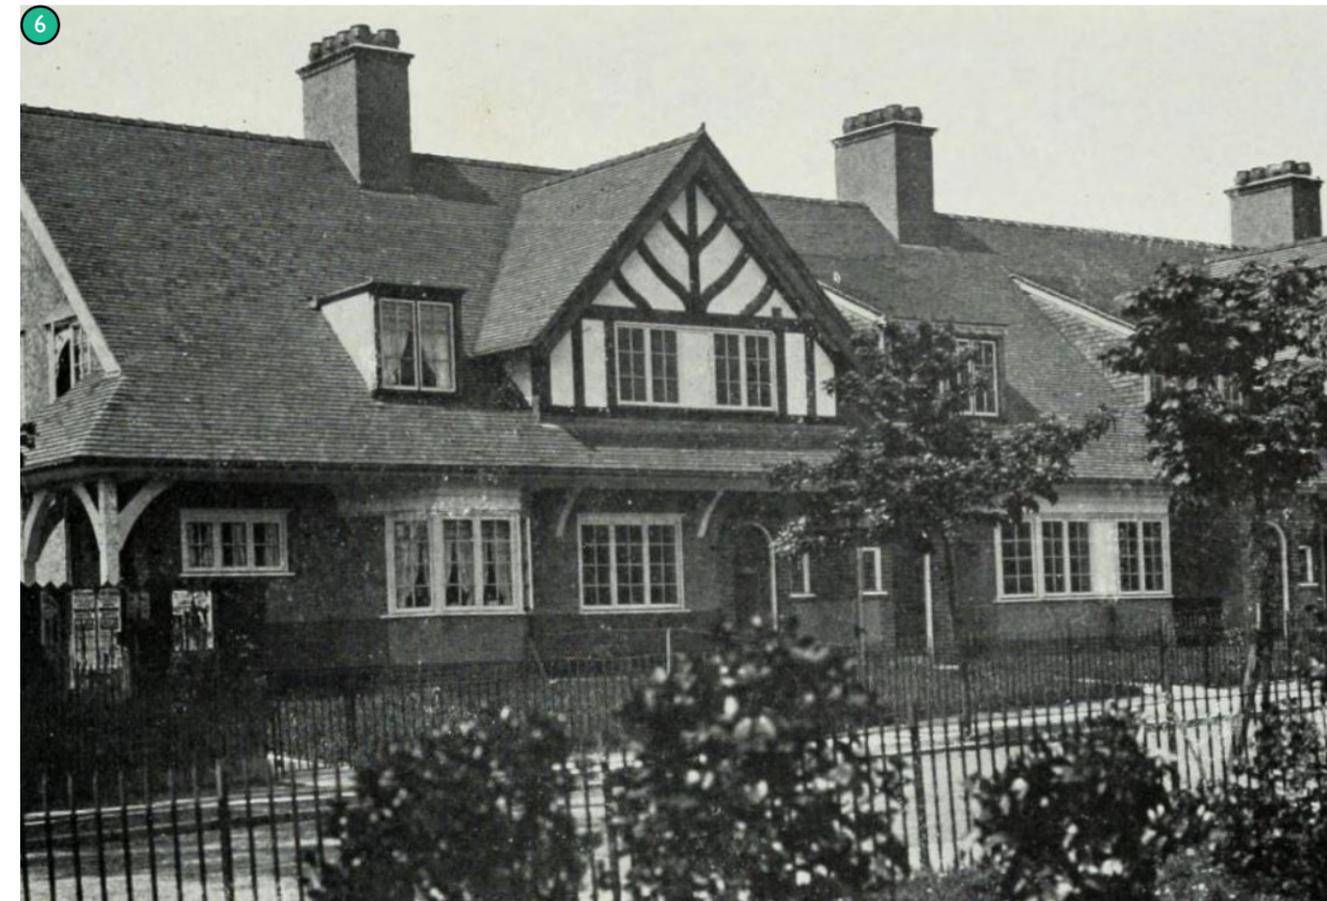
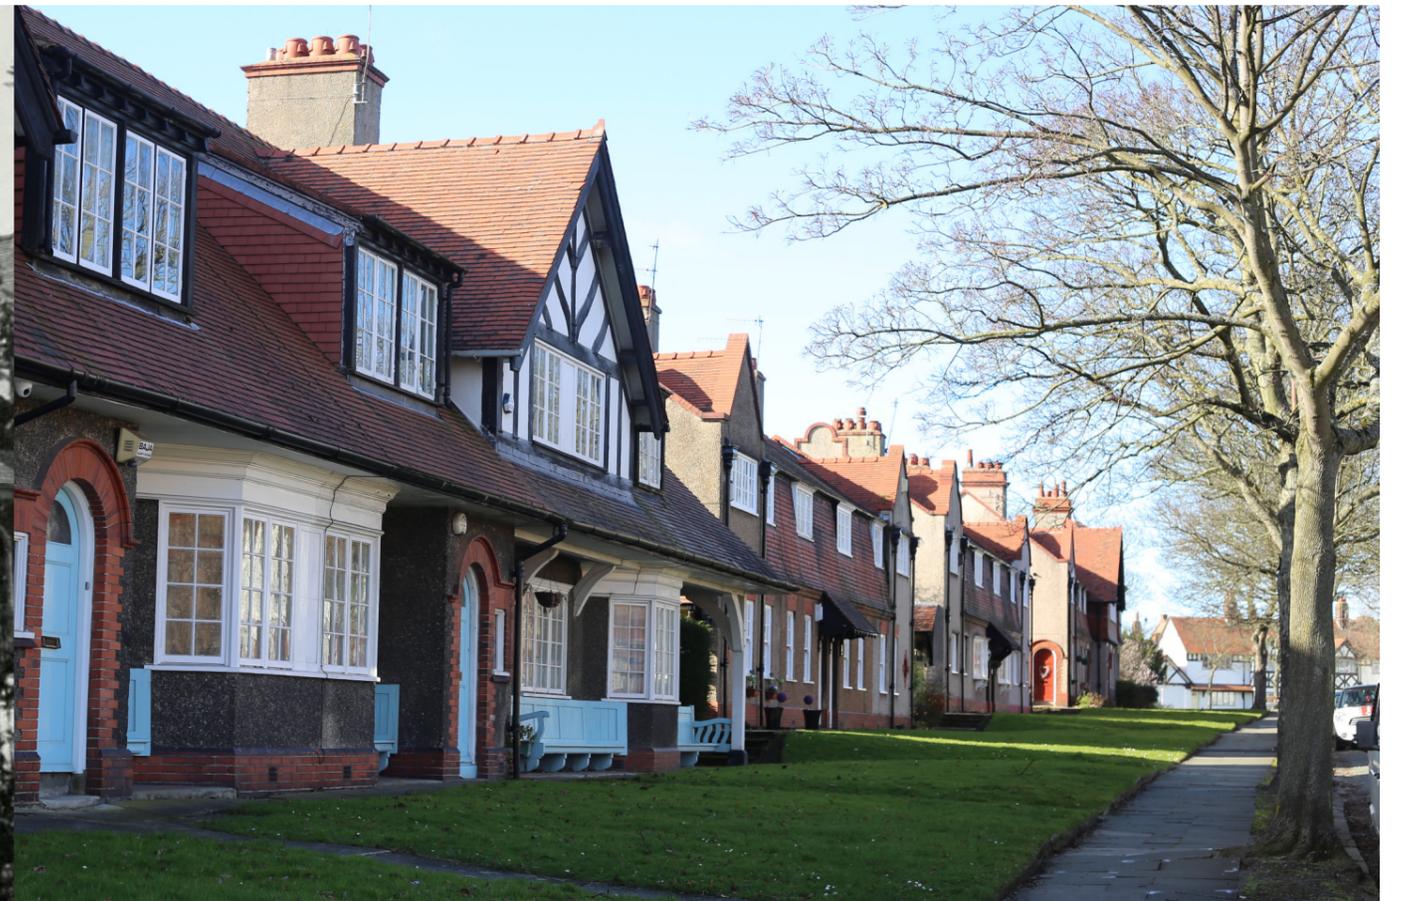
## Figure 6: Pool Bank

A tree lined street with shrub planting and mid-height railings to property frontages.

Even though the view focus is on the property, it is completely different from the original design or character through the loss of landscape features, primarily the boundary railings. Maintenance of this 'new' character along Pool Bank is recommended, as this mature and simplified character works well with the architecture of the properties. Tree management is required to sustain the current tree lined street character.

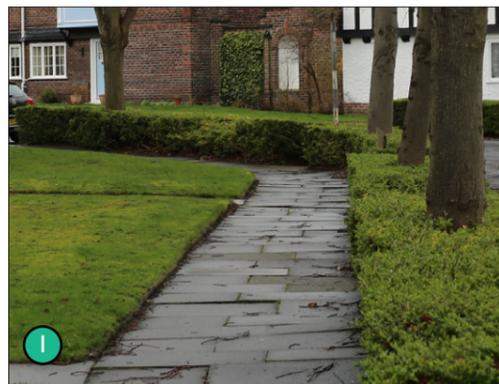
**Character Area 7**  
Uneven paving along Windy Bank

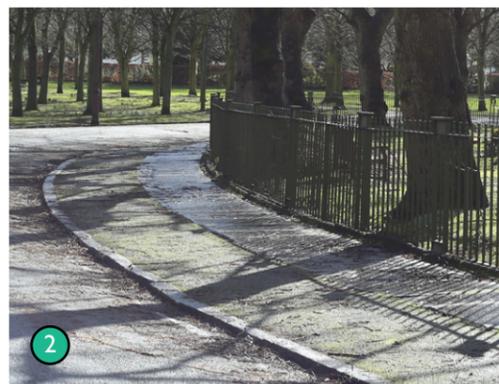
**Character Area 8**  
Paving outside the Christ Church.

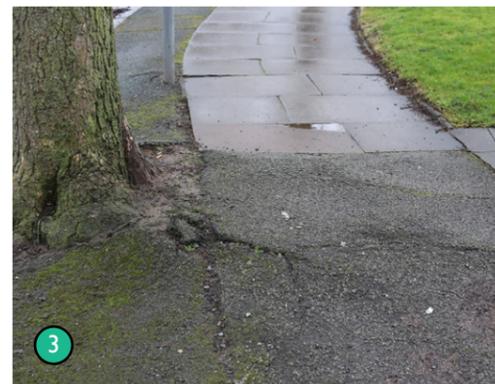
**Character Area 10**  
Root heave damage to pavement, Church Drive.

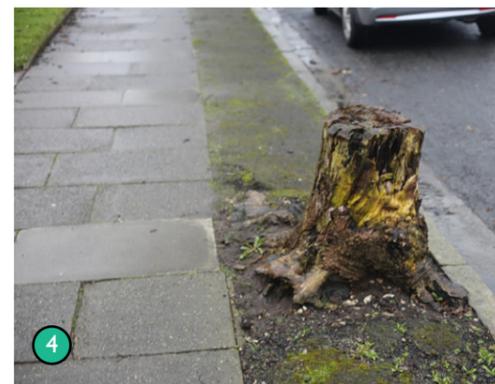
**Character Area 11**  
Leftover tree stump, Central Road.

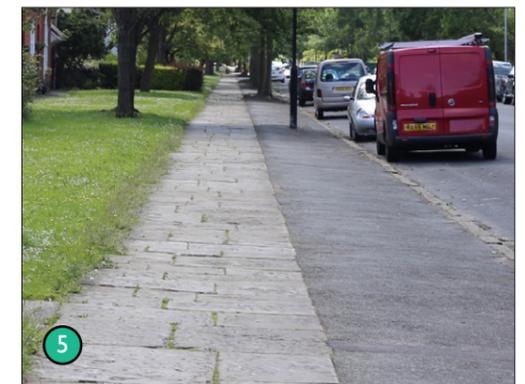
**Character Area 12**  
Acceptable condition paving along Greendale Road

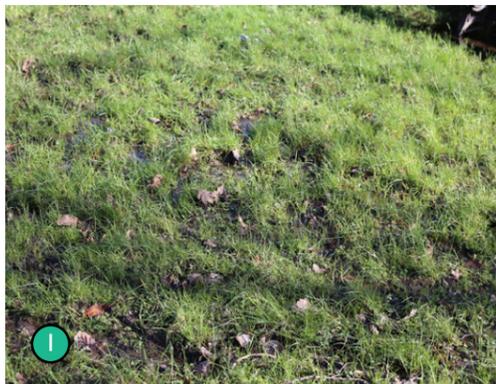
Weeds in grass in front of residential properties, Park Road.

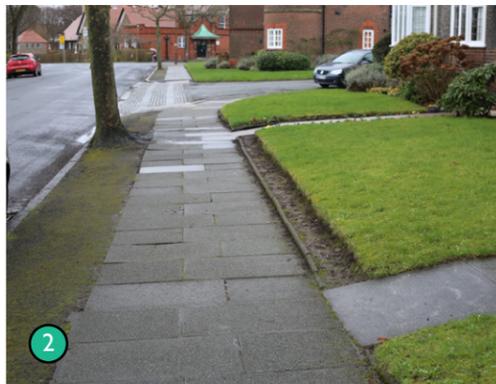
Unfilled gap strip, Park Road.

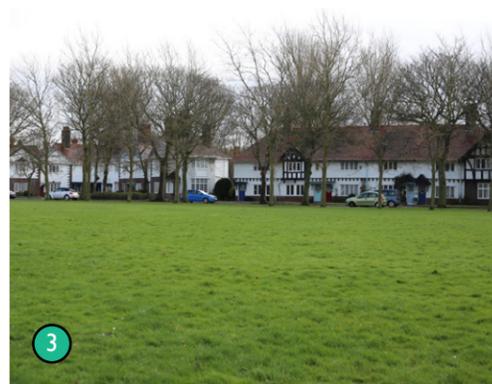
Well maintained grass, playing field, the Ginnel.

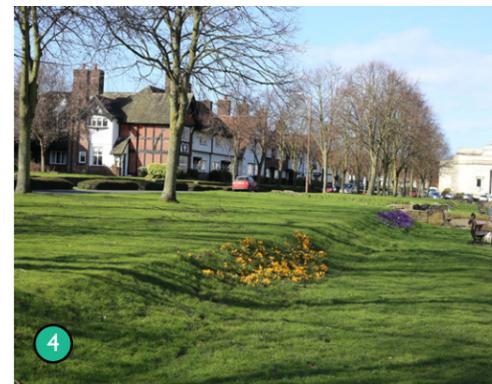
Well maintained grass with crocus bulbs in the Diamond.

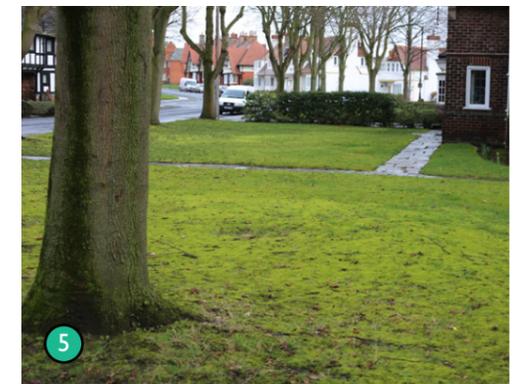
Moss in grass in front of residential properties.

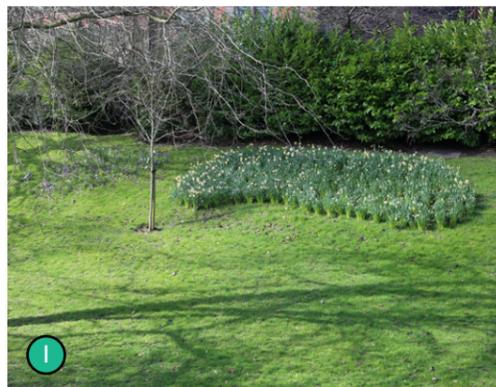
Bulb planting in the Dell.

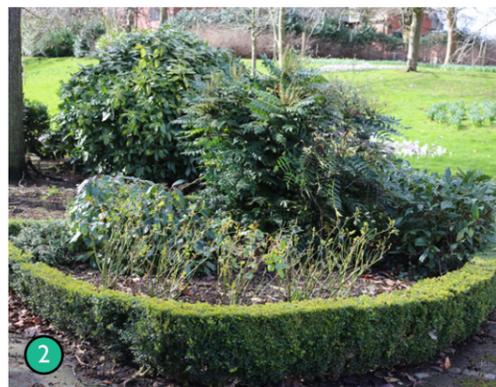
### Character Area 2

Formal shrub planting in the Dell.

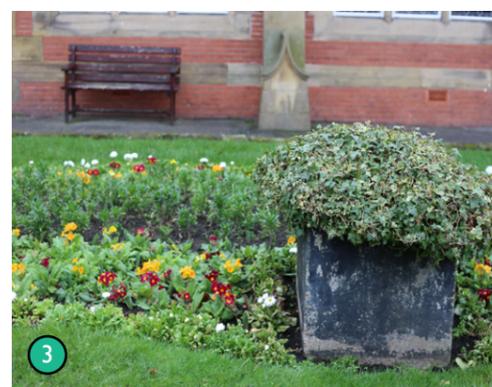
### Character Area 3

Planting bed outside Hulme Hall.

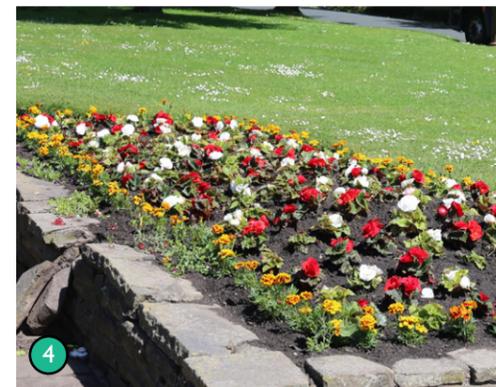
### Character Area 4

Seasonal planting in the Diamond.

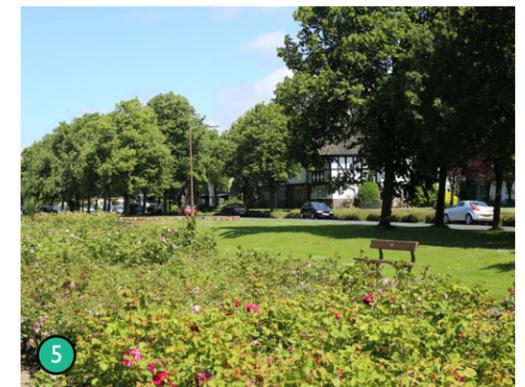
### Character Area 9

Rose planting in the Diamond.

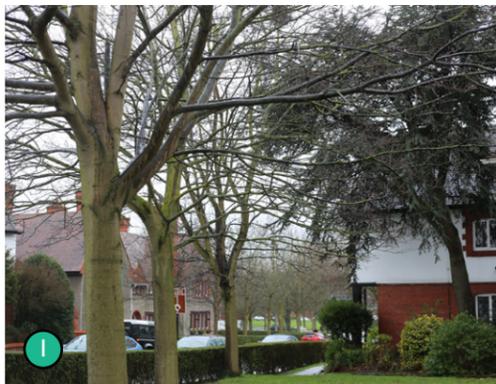
### Character Area 4

Trees in soft landscape in front of residential properties.

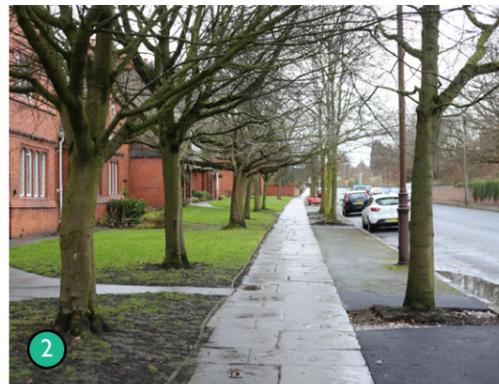
### Character Area 7

Trees planted in hard landscape along Greendale Road.

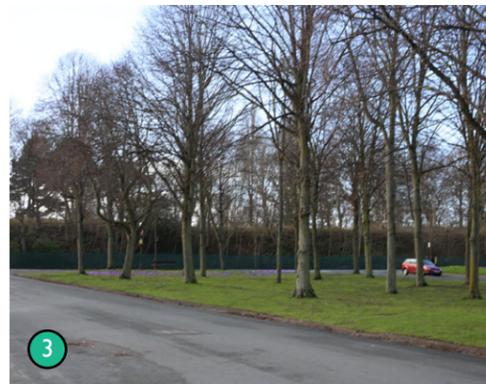
### Character Area 9

Trees planted in grass, The Causeway.

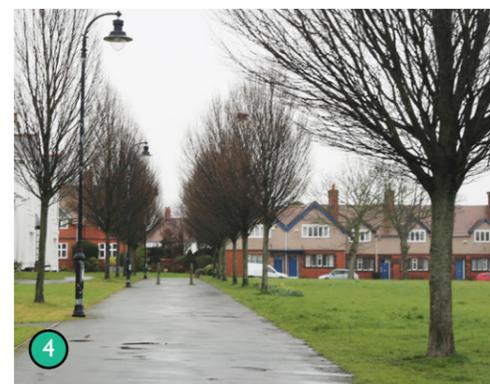
### Character Area 11

Trees planted along pedestrian pathway near Osborne Court.

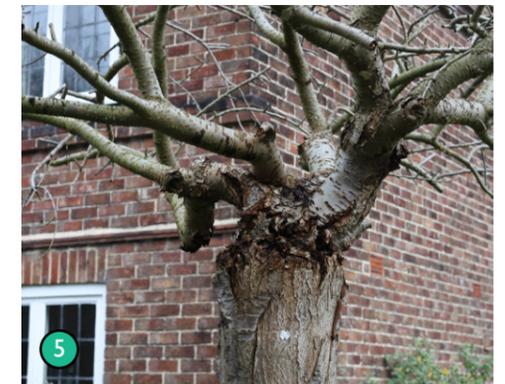
### Character Area 12

Tree in poor condition on the corner of Greendale Road.

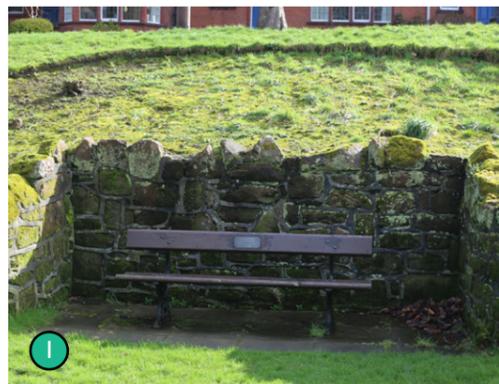
### Character Area 2

Memorial bench in the Dell.

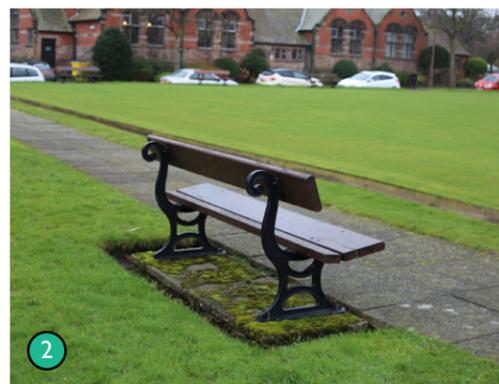
### Character Area 3

Bench at the bowling green, Bath Street.

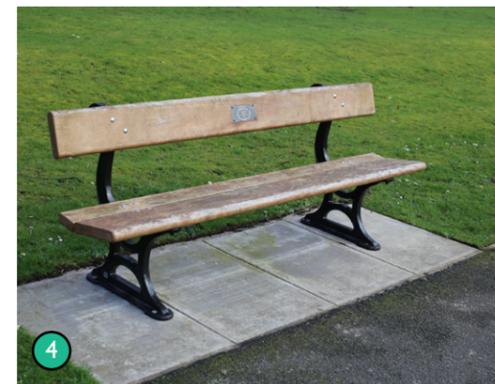
### Character Area 9

Memorial Bench in the Diamond.

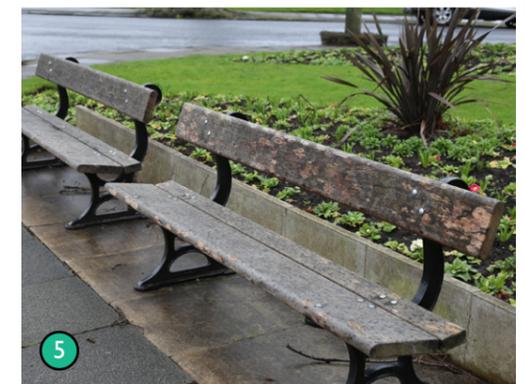
### Character Area 10

Benches outside the PSVT Museum.

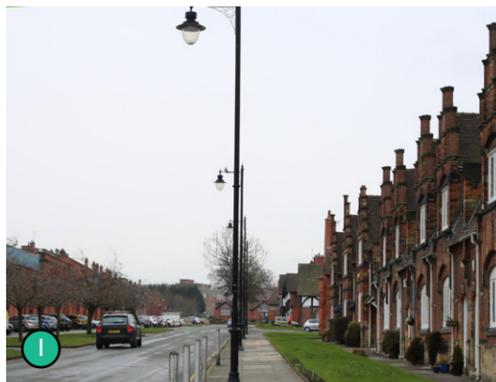
### Character Area 3

Reproduction lights along Wood Street.

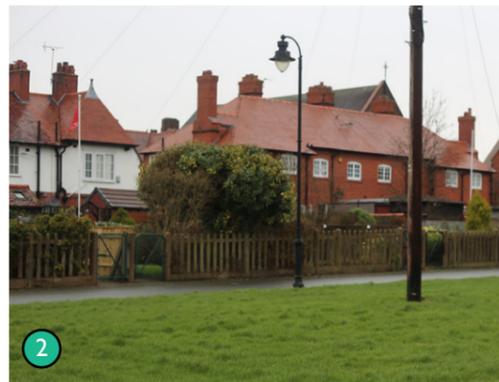
### Character Area 6

Back court lamp, rear of Bebington Road properties.

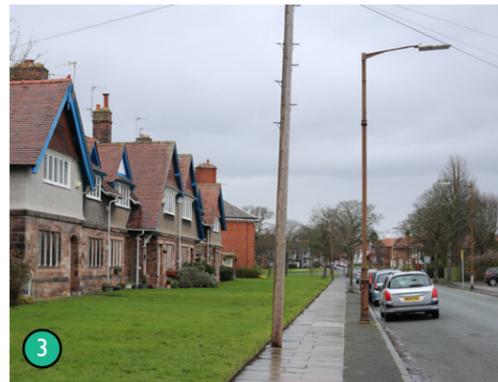
### Character Area 10

Modern post and luminaire, King George's Drive.

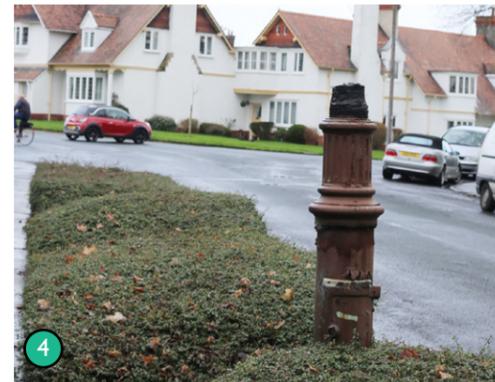
### Character Area 12

Lamp post base, Primrose Hill.

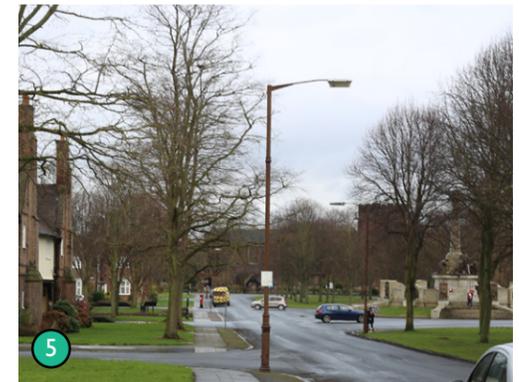
### Character Area 12

Street lamp, Windy Bank.

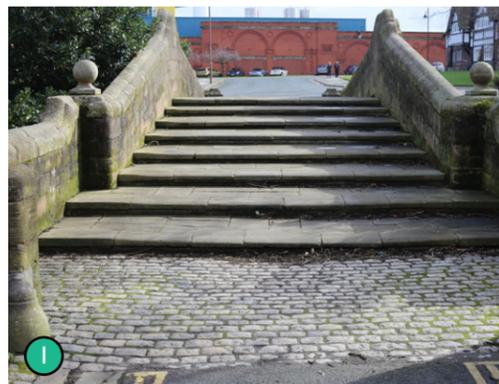
**Character Area 2**  
The Dell Bridge

There has been no significant changes since the 2007 Bureau Veritas report apart from an increase in the number of memorial benches and trees. The Dell Bridge is a key feature of this Character Area; its maintenance and management is paramount for its longevity as an important historical asset. A structural restoration survey is required as a priority with funding for restoration sought based on its findings. Drainage and flooding is a major issue particularly around benches and low points throughout the park. The recommendation would be the introduction of varied plant species which can better tolerate wetter conditions and or the potential creation of a wetland habitat, perhaps within the former Auditorium site, now a grass sunken area aiding in reducing maintenance activities. Any future landscape and policy changes to 'The Dell' should be in consultation with Historic England given its Registered Park and Garden Status.

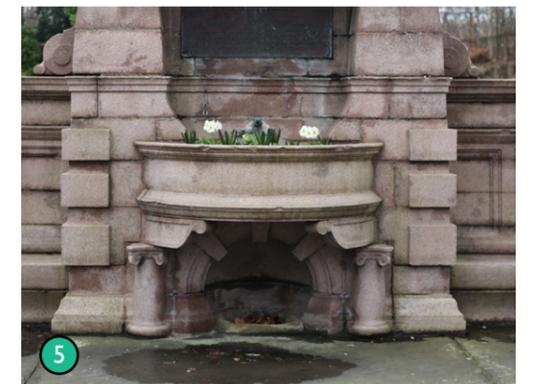
**Character Area 3**  
Silver Wedding Anniversary Fountain

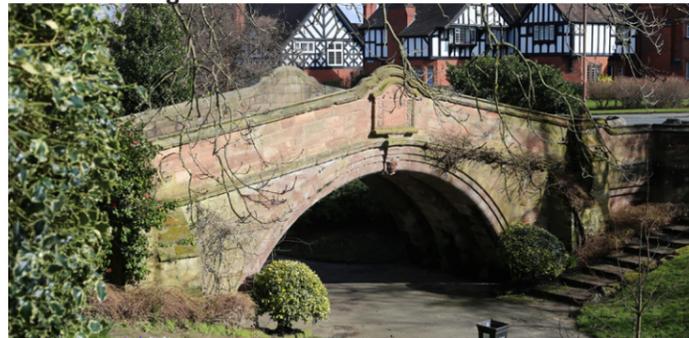
The Dell Bridge

**The Dell Bridge:** Removal of all planting, (except trees) within 2 metres of the bridge. Commission a full structural and condition survey for the upkeep, restoration and subsequent implementation.

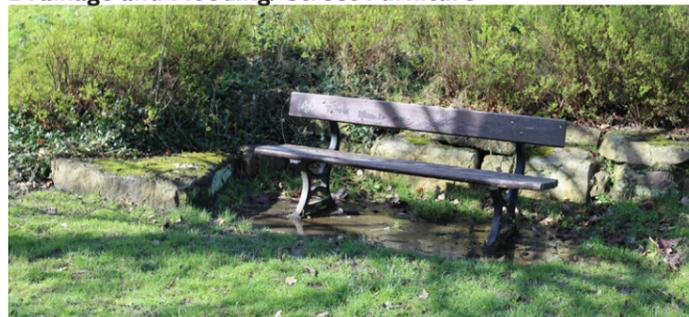
Drainage and Flooding/ Street Furniture

**Drainage and Flooding:** Commission a full hydrological and drainage survey of the Dell to base recommendations to tackle flooding upon. Development of a plant species list which can withstand damp/ wet conditions for inclusion, where appropriate.

**Street Furniture (e.g. benches, bins, signs, etc.):** Initiate a strategy and programme of street furniture maintenance activities including cleaning, painting or replacement if repair is not economically viable.

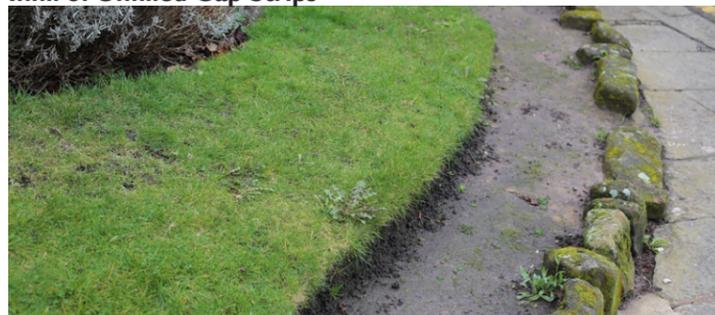
### Infill of Unfilled Gap Strips

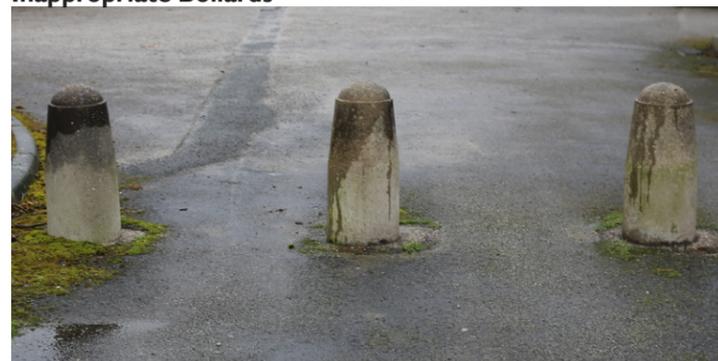
### Inappropriate Bollards

**Bollards:** Review with WMBC into suitable bollard to use throughout the village that is appropriate to the conservation area and heritage setting. Strategic replacement of inappropriate bollards, starting with the most obvious.

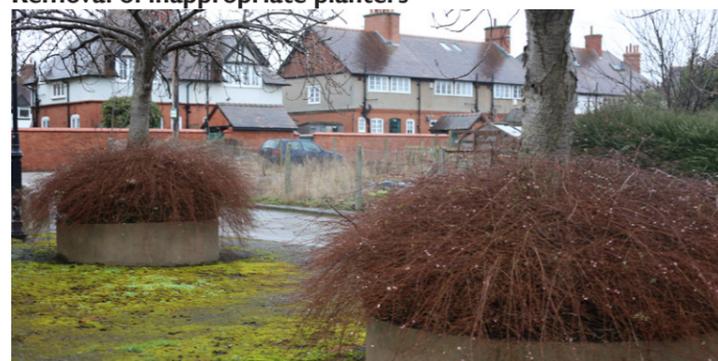
### Removal of inappropriate planters

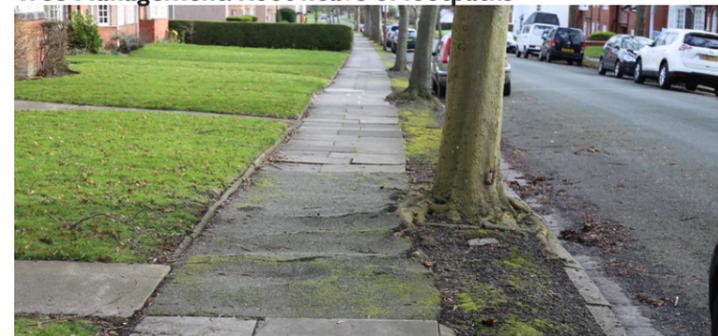
### Tree Management: Root heave of footpaths

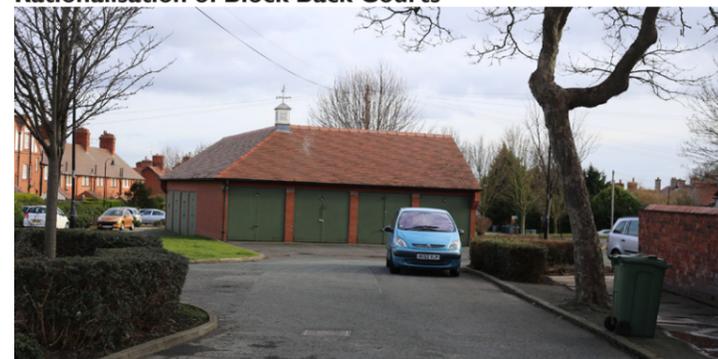
### Rationalisation of Block Back Courts

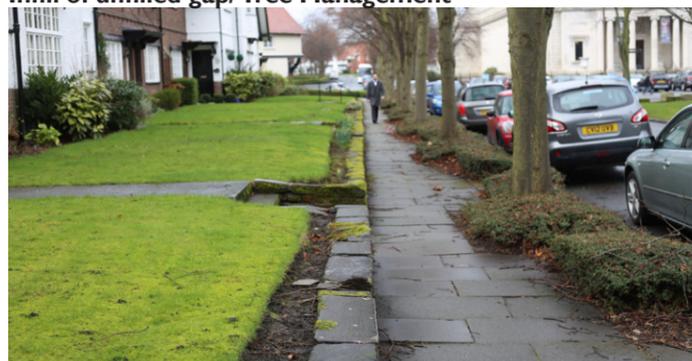
### Infill of unfilled gap/ Tree Management

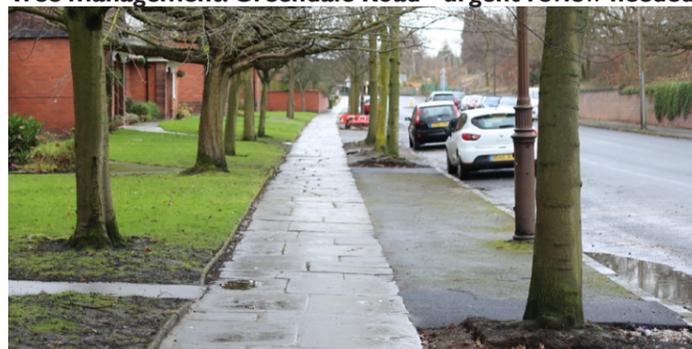
### Tree management: Greendale Road - urgent review needed

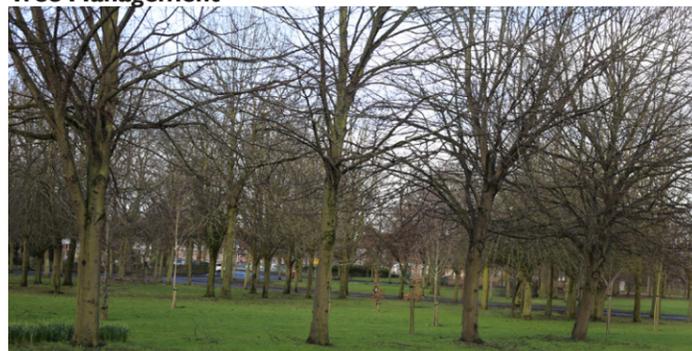
Tree Management

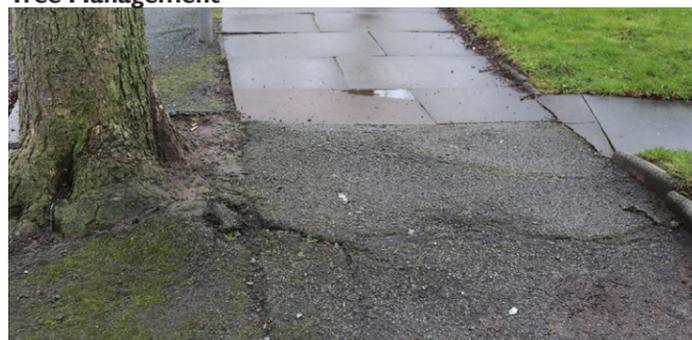
### Tree Management

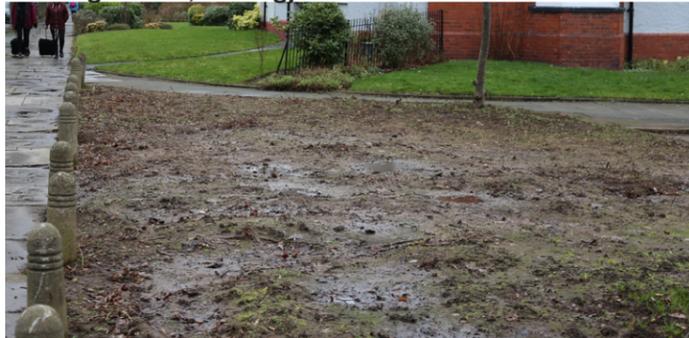
Planting Review, Strategy & Maintenance

**Planting Condition Review and Strategy:** A full survey of all planting beds including condition, health, vigour and longevity for simplification of planting styles/ initiatives to reduce long term maintenance activities:

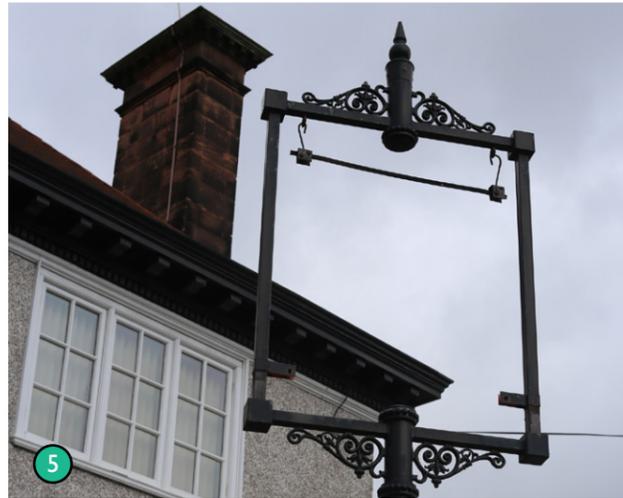
**Character Area 6**  
Incomplete sign, New Chester Road

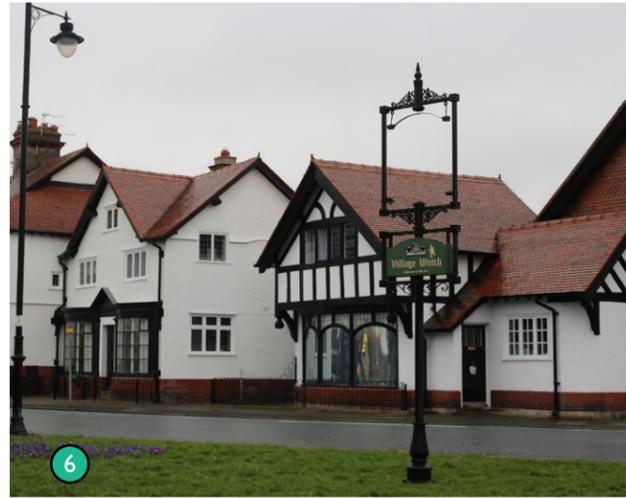
**Character Area 6**  
Incomplete name sign, Bowling Green

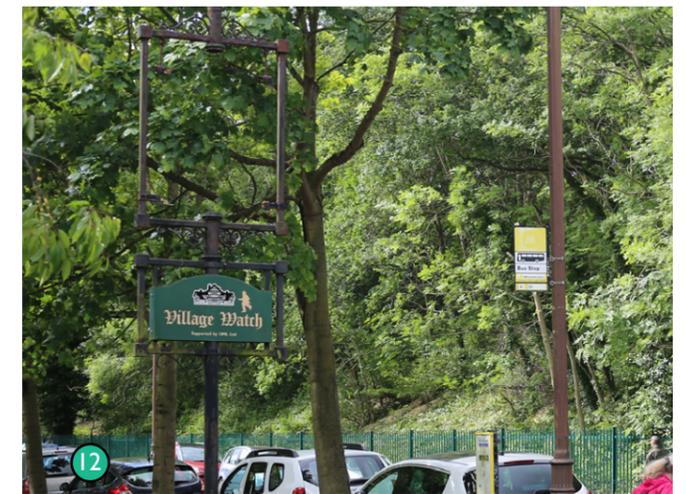
**Character Area 12**  
Incomplete name sign, Greendale Road

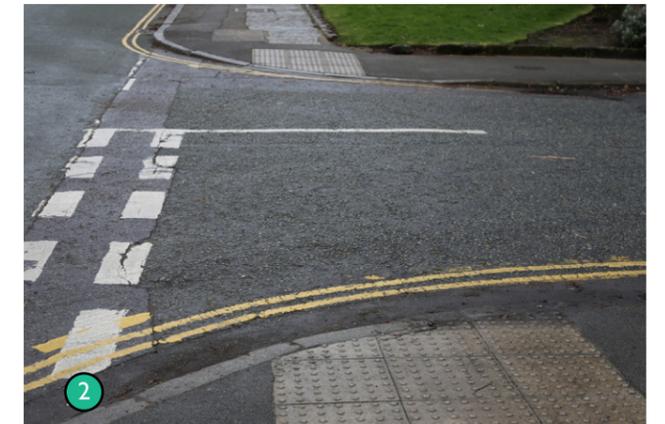
**Character Area 3**  
Example of a good crossing point, inconsistent throughout the village

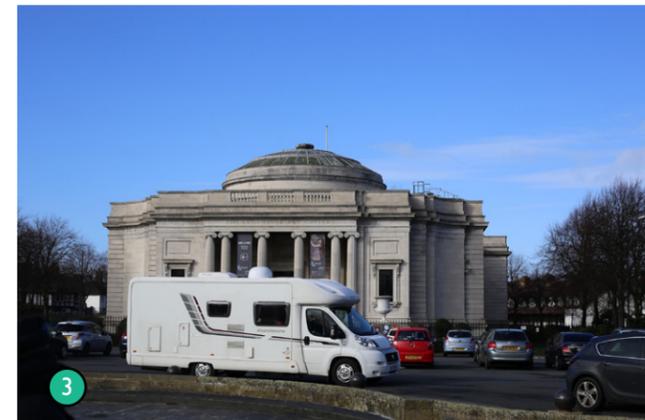
**Character Area 9**  
Informal parking in front of Lady Lever Art Gallery

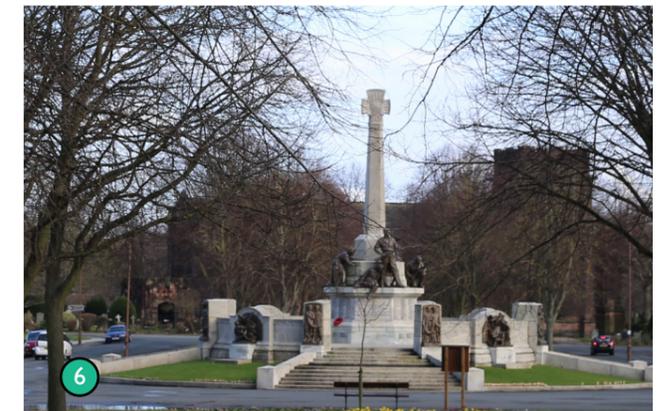
**Character Area 9**  
The War Memorial - lack of pedestrian navigation (for road crossing) or road markings for vehicle users
