# Port Sunlight Landscape Condition Survey Report

Port Sunlight Village Trust

Prepared by Ryder Landscape Consultants

July 2017

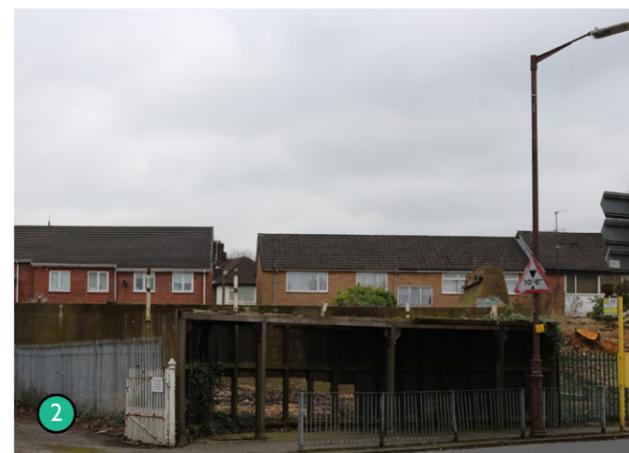
**Character Area 3**  
Disused Bus Stop next to the railway station, Greendale Road

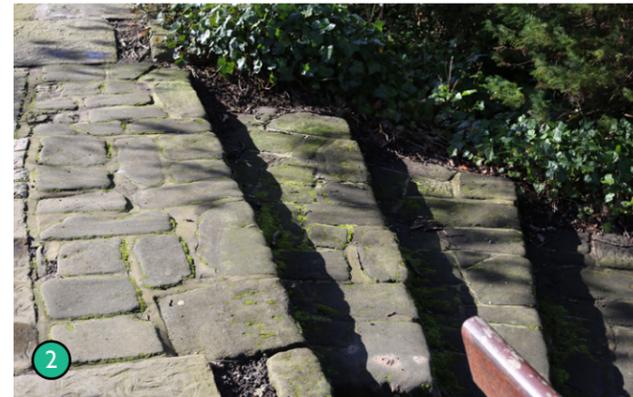
**Character Area 2**  
Steps into the Dell - trip/slip hazard, characterful but no handrail

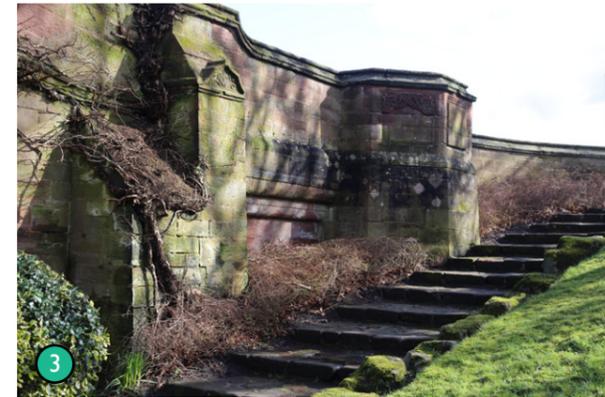
**Character Area 2**  
Steps into the Dell - trip/slip hazard

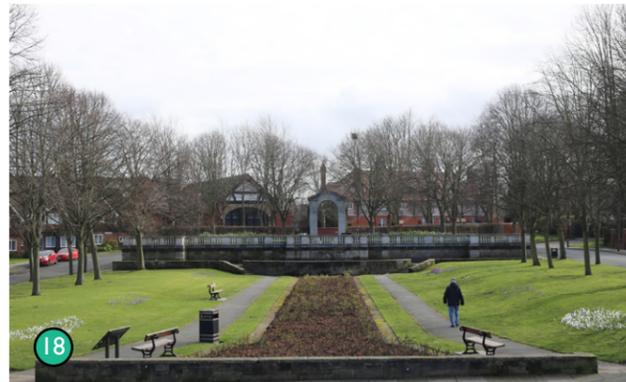
**Character Area 9**  
Lack of DDA compliant pedestrian access to the western part of the Causeway

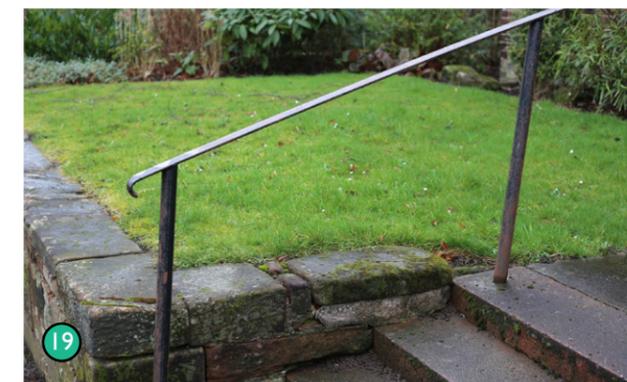
**Character Area 9**  
Lack of DDA compliant access to the southern part of the Diamond

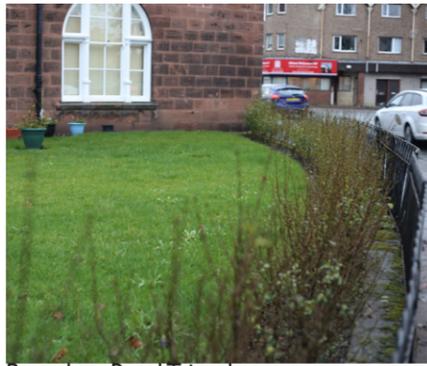
Boundary Road Triangle

1 These five spaces are deemed to have a high sensitivity to biodiversity potential as they provide key social amenity space for tenants/ residents outside or adjacent to properties and should be maintained in this manner.

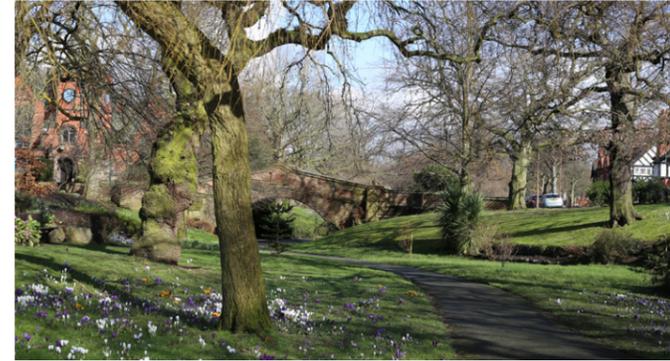
The Dell (West end): Formally laid out gardens prone to drainage issues more than the Dell mid-section or east end. Due to the proximity of social activities along Greendale Road and more established 'garden style' planting it is deemed to have less potential for biodiversity improvement.

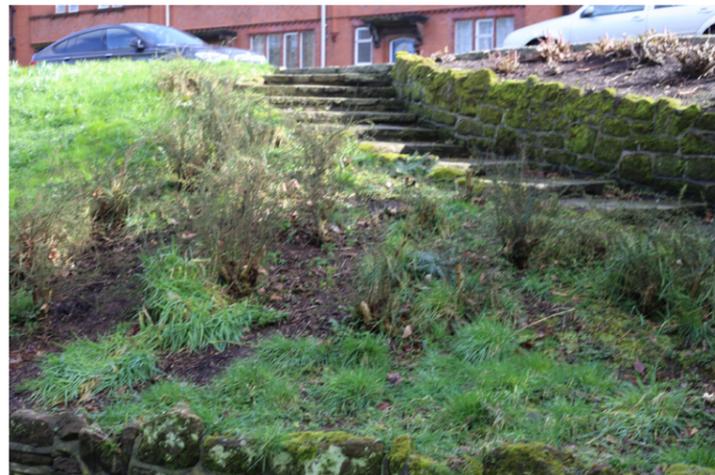
The Dell (mid-section)

The Dell (mid-section): The lowest part of the Dell, prone to drainage issues with planting failings and/or large gaps.

- Wildflower meadow (suitable for wet/damp conditions);
- Box hedging surrounds the space, is a high maintenance activity in terms of pruning;
- Infill planting (different species) within hedge gaps; and
- Reduction in hedge maintenance to encourage wildlife habitat creation.

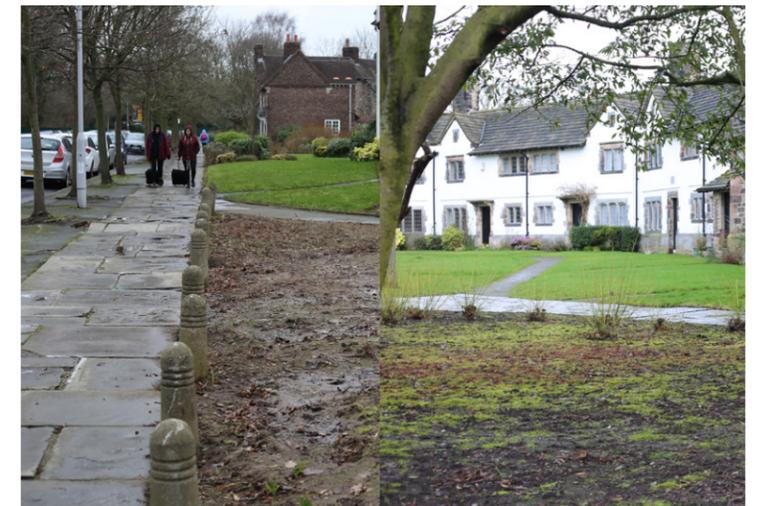
Greendale Road

Duke of York Cottages/ Greendale Road: Amenity planting in a poor condition with empty planting beds and heavily pruned shrubs.

- Appropriate groundcover shrub planting.

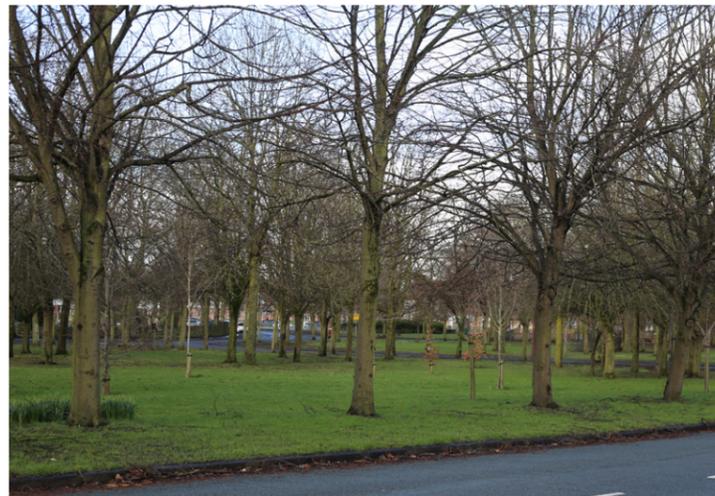
Corniche Road

Corniche Road: A high density tree planting area, which has been recommend for pruning, crown lifting, canopy reduction or selective removal to open up the space and increase potential use of the space.

- Additional planting or alternative planting within selected appropriate areas for habitat creation;
- Additional bulb planting; or
- Wildflower meadow or annual display mix.

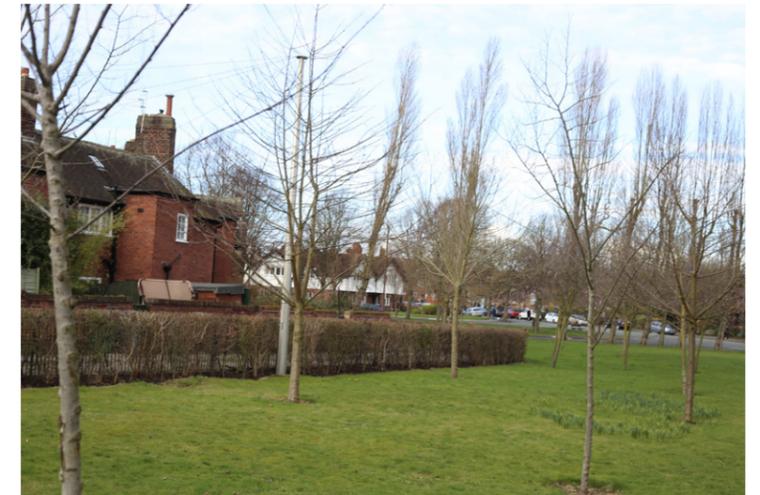
Church Drive: An area noted for future development. Until such time the space requires reactivation, to benefit the local community socially and for biodiversity and sustainability enhancement of the village; especially with the significant poplar tree planting to the periphery along Church Drive and implementation of tree planting on the western edge to the rear of Jubilee Crescent properties.

- Longer grass or wildflower meadows within the recently trees along the western edge, to increase habitat potential, reduce grass mowing and provide seasonal interest.

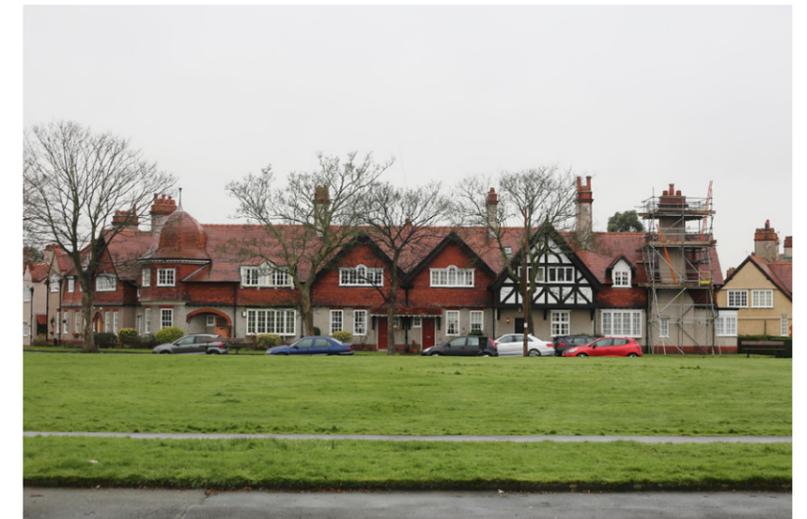
Potential interventions to increase biodiversity and sustainability are:

- Additional bulb planting;
- Long grass;
- Wildflower meadow; or
- Additional infill planting to form more diverse habitat.

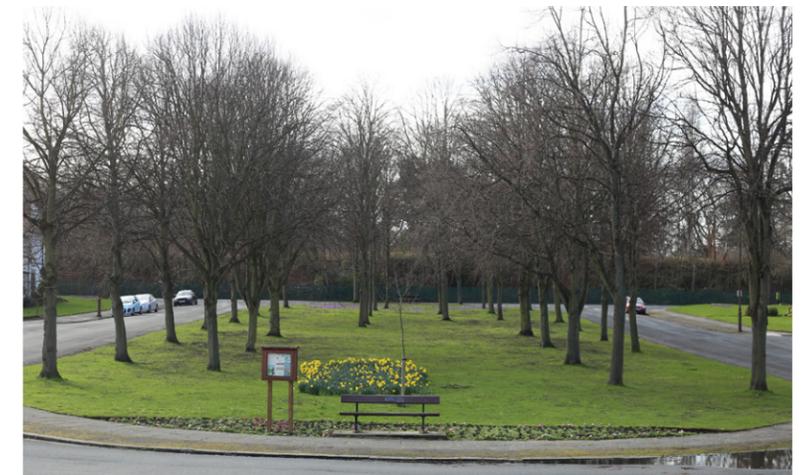
## **4** Character Area 9: The Civic Cross (The Diamond and the Causeway)

The Causeway: An open grass space with nearly mature trees, with limited public access or usability. Could provide small scale biodiversity opportunities which add interest.

Potential interventions to increase biodiversity and sustainability are:

- Additional bulb planting;
- Removal of bedding planting;
- Long grass to central area with mown edge strip; and
- Wildflower meadow or annual wildflower displays.

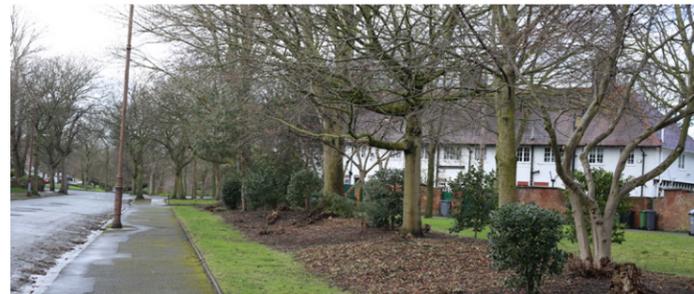
Warf Street/ Water Street

Warf Street/ Water Street: Potential for further development of this space as green corridor within the village, using existing trees, shrubs and ground cover.

Potential interventions to increase biodiversity and sustainability are:

- alteration of management regimes e.g. reduction in pruning;
- long grass;
- wildflower meadow; and
- additional habitat encouraging planting.

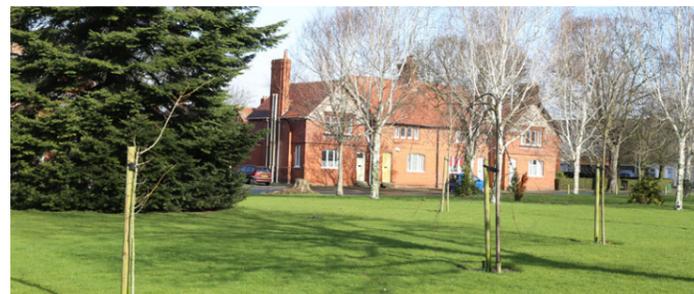
Lower Lane/ Corniche Road

Lower Lane/ Corniche Road: An open space with significant tree planting at various stages, this could become a key biodiversity area through the various tree species in the form of a village arboretum.

Potential interventions to increase biodiversity and sustainability are:

- Additional tree planting of exotic varieties;
- long grass and wildflower planting - reducing mowing maintenance activities.

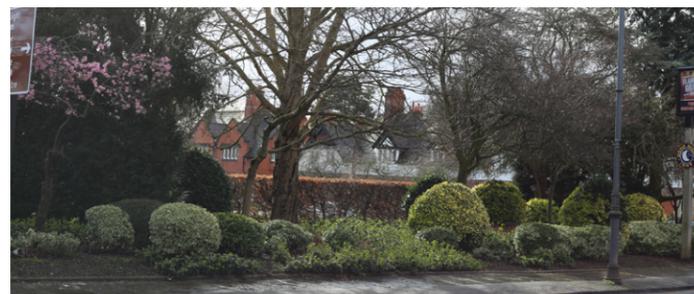
Bolton Road

Bolton Road: Amenity planting verge with high maintenance demands, as a key access corridor through the village. These verges can continue to provide amenity value as well as biodiversity and sustainability opportunities.

Potential interventions to increase biodiversity and sustainability are:

- Infill and simplification of planting and a reduction in maintenance of some species to encourage wildlife habitat.
